FAILURE ANALYSIS

OF ELASTOMER COMPONENTS

Incorrect Installation Space -**Details Can Make the Difference**

Authors: Dipl.-Ing. Bernhard Richter, Dipl.-Ing. (FH) Ulrich Blobner

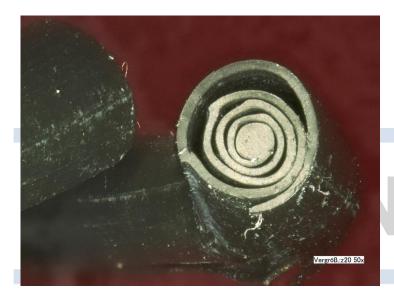
Cross structures to the circumferential direction must be avoided. With dynamic seals, the surface quality should ensure a minimum of friction and wear. In addition to the roughness depth, the contact area percentage is also important. Regardless of the influence of the gap dimensions on eccentricity, it must be ensured that no unacceptable gap penetration occurs under maximum pressure, see **Fig. 1**.

Fig. 1: Effect of a sharp-edged groove design - the O-ring peels off at the groove edge (350 bar pressure, gap 0.05 mm)

Sharp edges, e.g. unrounded grooves, must be avoided as they can produce small cuts that can propagate under operating conditions.

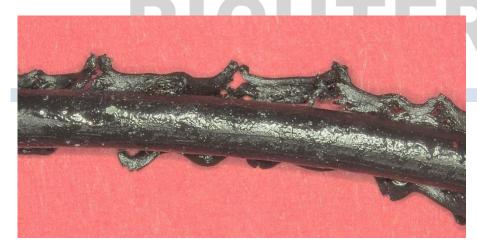
A typical groove overfill can be recognized by compressed (already during assembly) or frayed edges. Material drives on both sides are typical for this type of damage, see **Fig. 2**.

Fig. 2: O-ring crosssection after a typical groove overfill: The squeezed areas can be seen above and below.

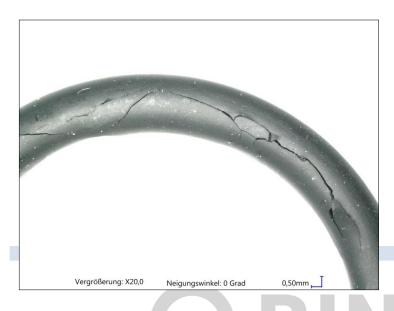
If the deformation is too large, stress cracks appear in **Fig. 3** inside the seal and then propagate outwards.

Fig. 3: EPDM O-ring, destroyed by excessive deformation and thermal impact (stress cracks)
