EXPERT KNOWLEDGE
FAILURE ANALYSIS
OF ELASTOMER COMPONENTS
SHORT VERSION

Ozone Cracks –
A Common, but Preventable Cause of Failure

Authors:
Dipl.-Ing. Bernhard Richter,
Dipl.-Ing. (FH) Ulrich Blobner

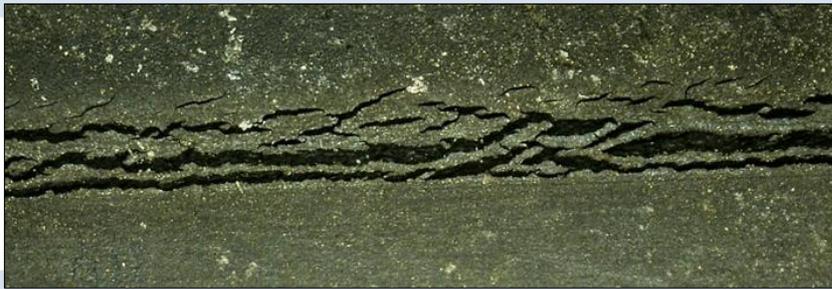
Ozone cracks always appear perpendicular to the direction of the stress (**Fig. 1**). The cracks are deep and can lead to the tearing of the seal. The damage is irreversible and can only be repaired by replacing the seal. In practice, the damage pattern can easily be confused with other damage patterns: the damage pattern of ozone cracks is similar to the damage pattern of fatigue cracks caused by cyclic dynamic loading (**Fig. 2**). For a damage assessment, the type of stress must be known. Then, a clear differentiation is possible. It is easier to determine seal damage caused by chemical erosion. It can be seen in the greater depth of the cracks and in a stress-dependent, which is normally parallel, orientation of the cracks.

Fig. 1: Cracks in statically pre-stretched bellows made of BR/IR elastomer

- Seals with modified rubber formulation (e.g. use of ozone protection agents or ozone protection waxes).
- Seal coatings that reduce ozone susceptibility.
- Blending the damaged rubber with ozone-resistant rubbers or PVC.
- Use of a higher quality and ozone-resistant M, Q or O rubber. The often higher costs usually quickly pay off over longer service lives and system availability.
- Design measures (e.g. reduction of the ambient air inlet to the damaged seal or minimization of the gas inlet by flow of fluids).
- Logistical measures: seals susceptible to ozone cracking should never be stored under tension.

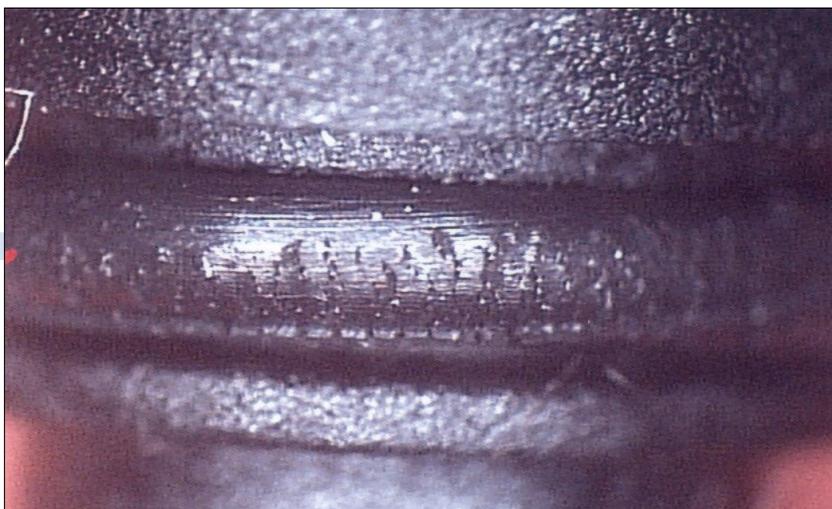
Fig. 2: The ozone cracks resemble fatigue cracks - here ozone cracks using the example of an NBR O-ring

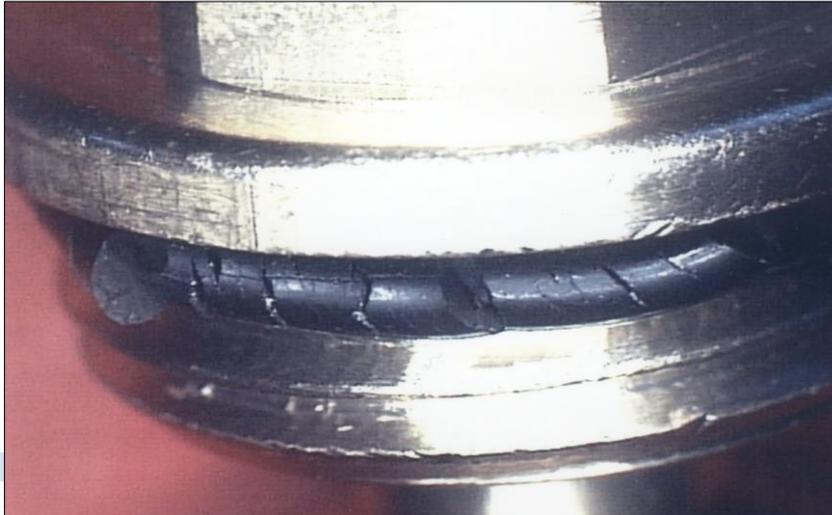
Ozone cracks often appear on pre-assembled components if they are directly exposed to ambient air during intermediate storage (see **Fig. 3**). The sealing damage can occur here already after a few days. The consequences are leakages up to a total seal failure (tearing of the seal), which can lead to a failure of the entire system.

Fig. 3: Pre-assembled NBR O-ring, which after a few weeks of storage became very severely cracked
