FAILURE ANALYSIS

OF ELASTOMER COMPONENTS

Cracks as a Result of Manufacturing Problems – A Severe Fault that Often Leads to Seal Failure

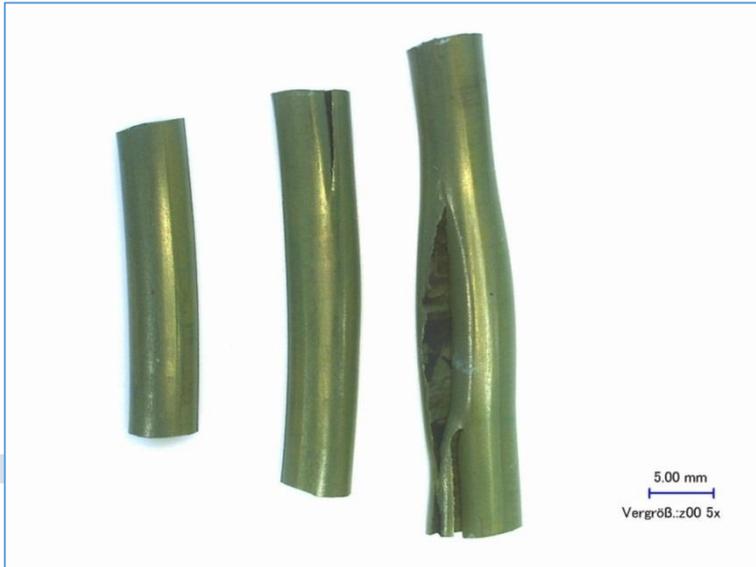
There are polymers, such as ACM materials, which are particularly sensitive to temperature control, but if production parameters are not optimal, cracks can also occur in all other elastomers due to vulcanization defects: If vulcanization is to be accelerated too much by high temperatures, any compound can vulcanize too early. In the application, this may only reveal itself under deformation and high temperatures (see **Fig. 1**).

Fig. 1: Cracks in an FKM O-ring due to over-vulcanization after a compression set test of 168h / 200°C

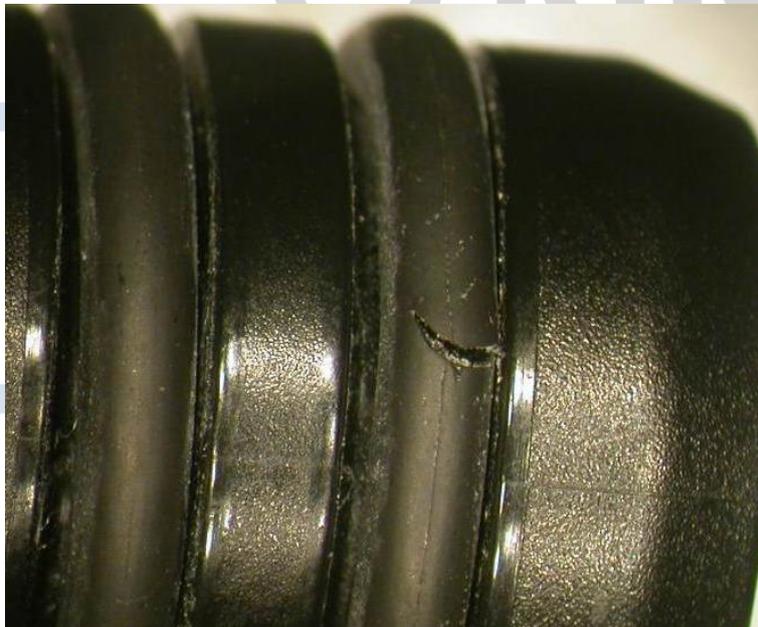
Cracks caused by flow lines are often parabolic and symmetrical to the mold parting line (see **Figs. 2 to 4**). In the case of faulty vulcanization, an inhomogeneous fracture point usually appears in the area of the fracture point (see **Figs. 5 and 6**), sometimes there are also conspicuously smooth areas in the fracture surface. Typical for cracks caused by vulcanization defects is also a rounded transition from the surface to the crack (see **Fig. 7**) compared to a case of damage caused by a cut

Fig. 2: Crack due to a vulcanization defect, recognizable by the parabolic crack shape symmetrical to the mold parting line

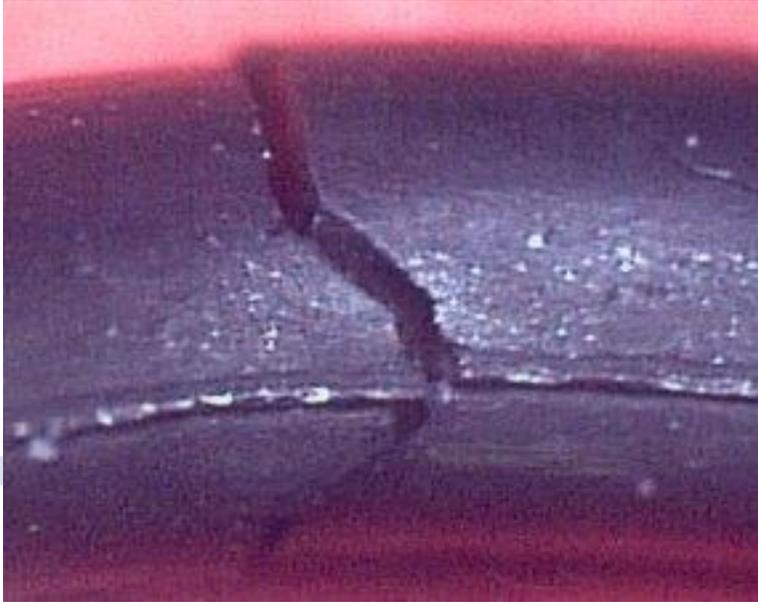
Fig. 3: Manufacturing crack, parabolic and symmetrical to the mold parting line

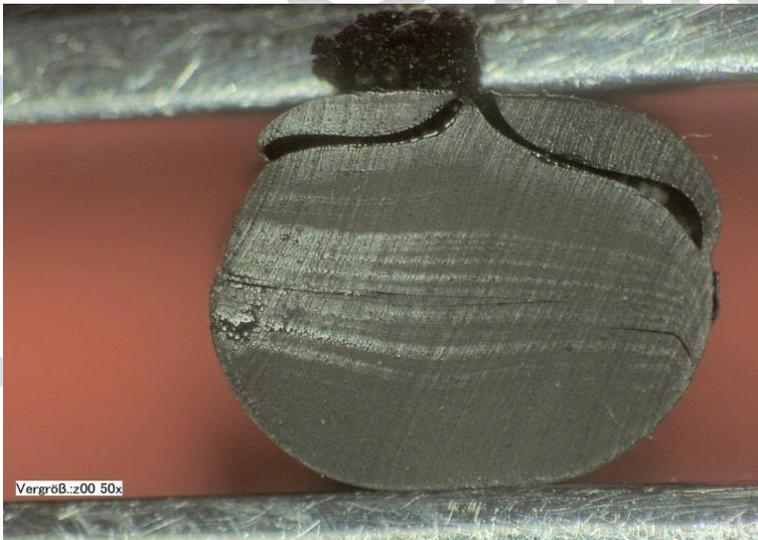
Fig. 4: Cracks due to a super-imposed elastomer compound

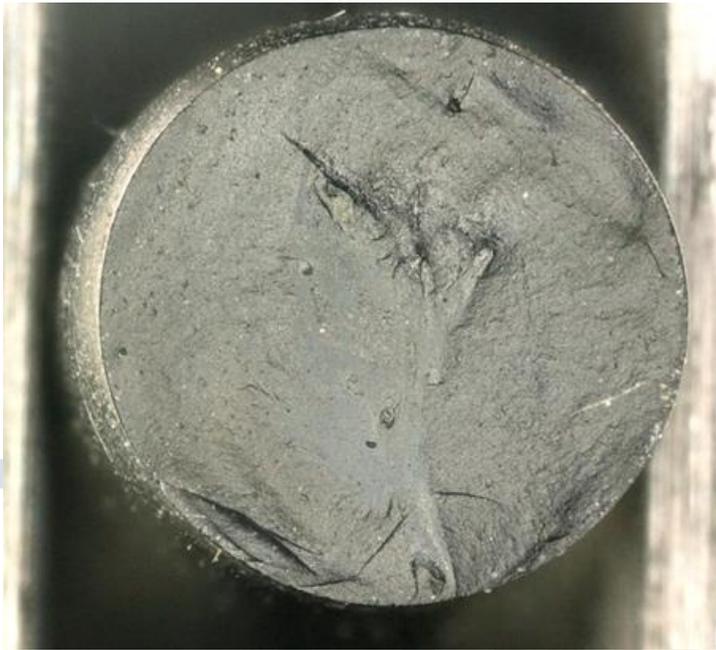
Fig. 5: Torn O-ring caused by a vulcanization error

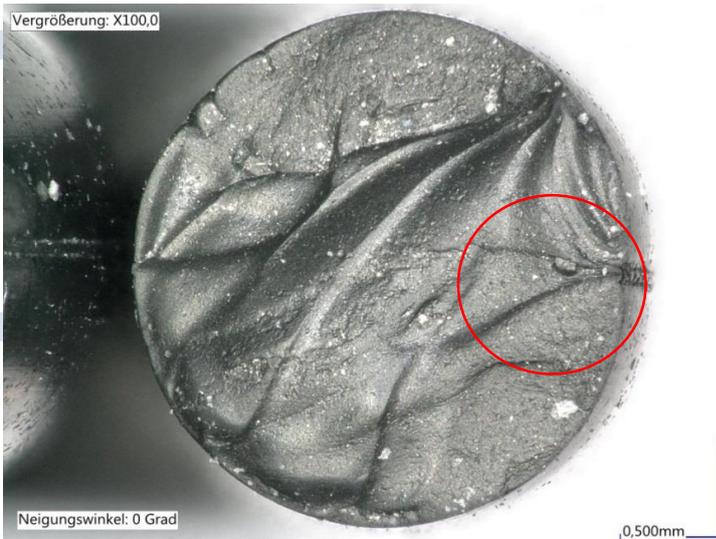
Fig. 6: Torn O-ring due to vulcanization defect: Inhomogeneous, fissured fracture surface

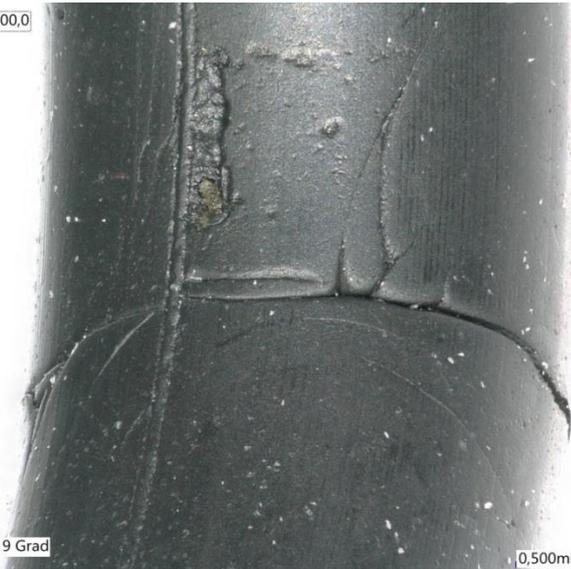
Fig. 7: Vulcanization defects due to production: Rounded crack transition (same O-ring as in Fig. 4)

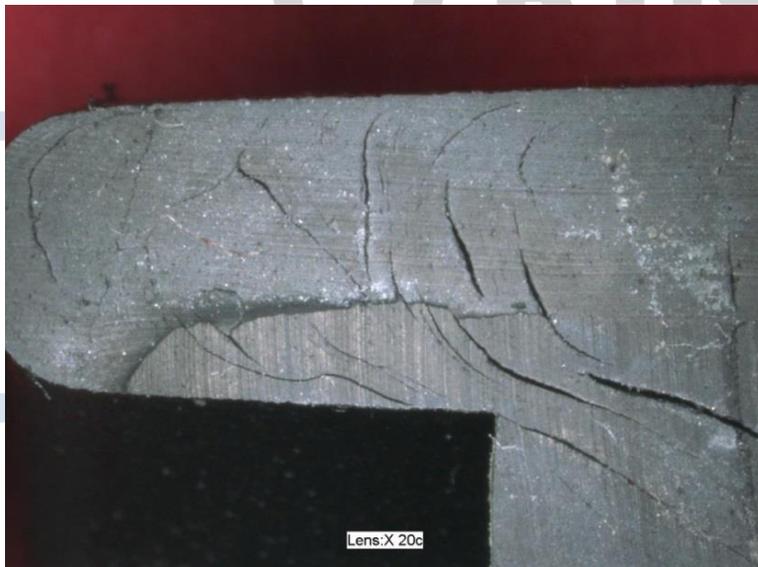
Fig. 8: Production-related cracks due to a superimposed compound

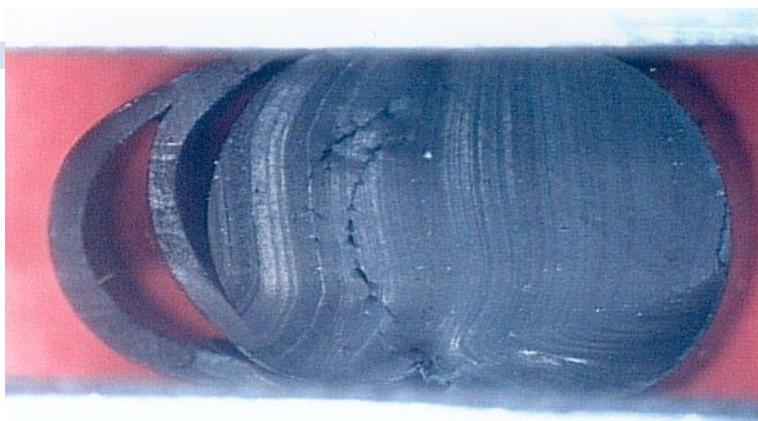
Fig. 9: Cracks or peeling on an O-ring due to faulty vulcanization (cause: superimposed compound)

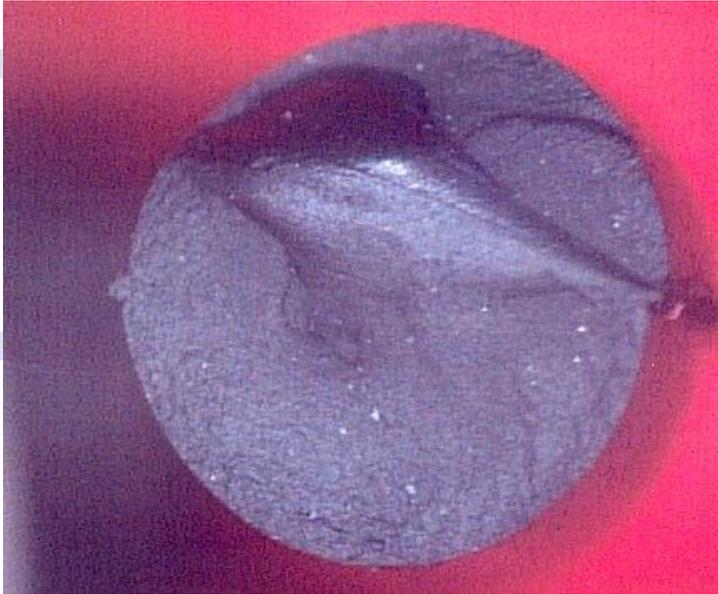
If foreign particles are detected on a cracked seal in the area of the fracture surface with a microscope, they can be the trigger for the crack (see **Figs. 10 and 11**). Today, the FT-IR microscope and/or the REM-EDX analysis are available for a more in-depth analysis of the foreign material.

Fig. 10: Manufacturing crack due to foreign material (mold release agent)

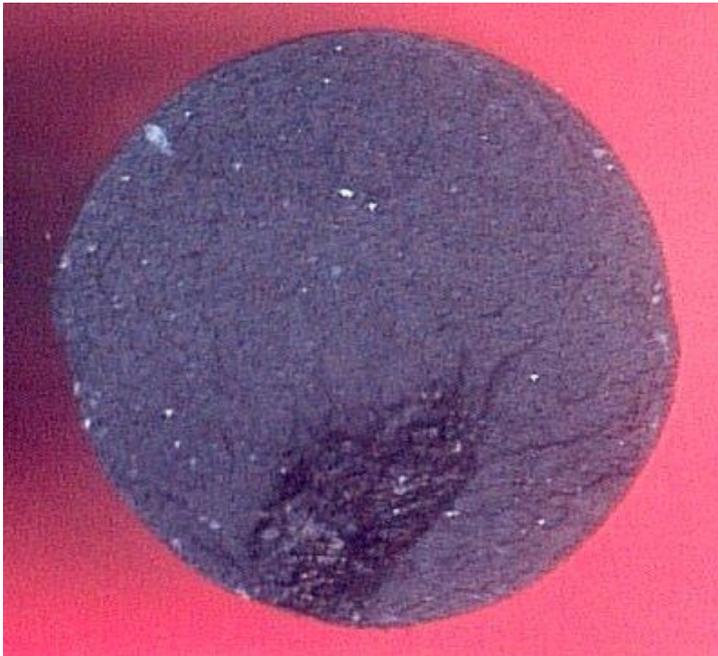
Fig. 11: Crack triggered by foreign material entry

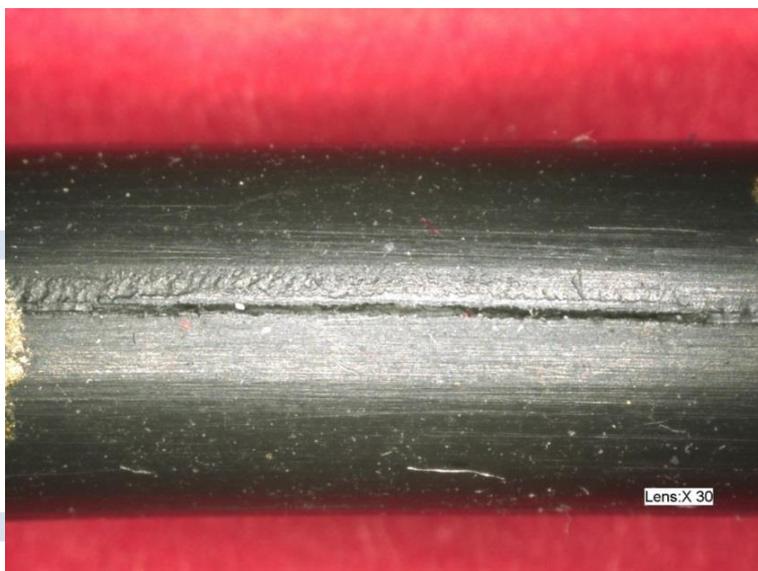
This type of crack starts at the parting plane (see **Figs. 12 and 13**). Often in the cross section of an O-ring a circumferential entry point with a wide "U" or "W"-shaped cross section (see **Fig. 14**) can be seen. The draw-in point is a flat, plate-shaped depression, sometimes triangular in section at the parting line at the inner and/or outer diameter. This is caused by damage of the tool edge and/or the high shrinkage factor of rubber.

Fig. 12: Shrinkage crack on an O-ring

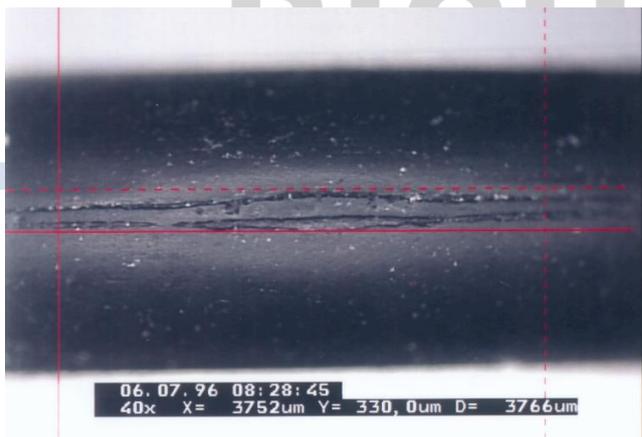
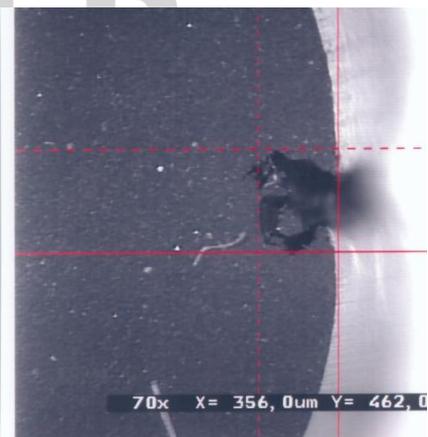
Figs. 13 and 14: Shrinkage cracks at the tool parting plane of an O-ring and on the right in a cross-cut O-ring

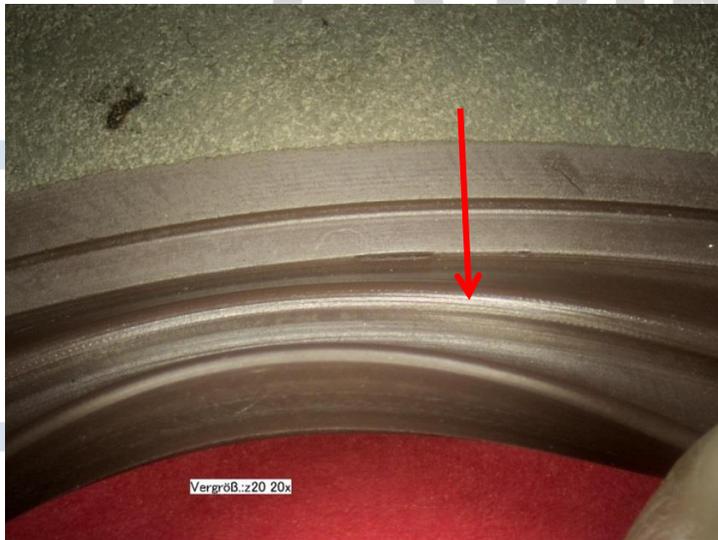
These often occur at sharp transitions, edges (see **Fig. 15**) or undercuts (see **Fig. 16**). In addition, an excessively high demolding temperature can favor this.

Fig. 15: Demolding crack on a molded gasket

Production problems can already be reduced or avoided in advance through rubber-compatible component design. For example, edges on the molded gasket, where demolding cracks can occur regularly, should be structurally defused (e.g. by radius, avoidance of undercuts).

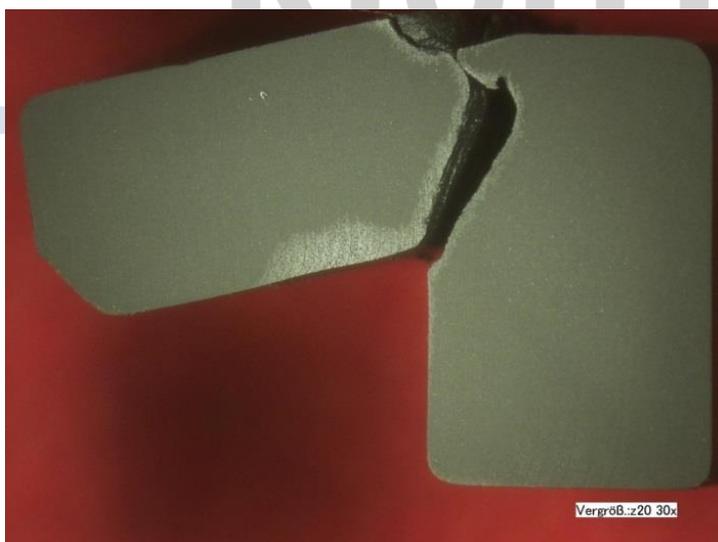
Fig. 16: Demolding crack at a sealing element

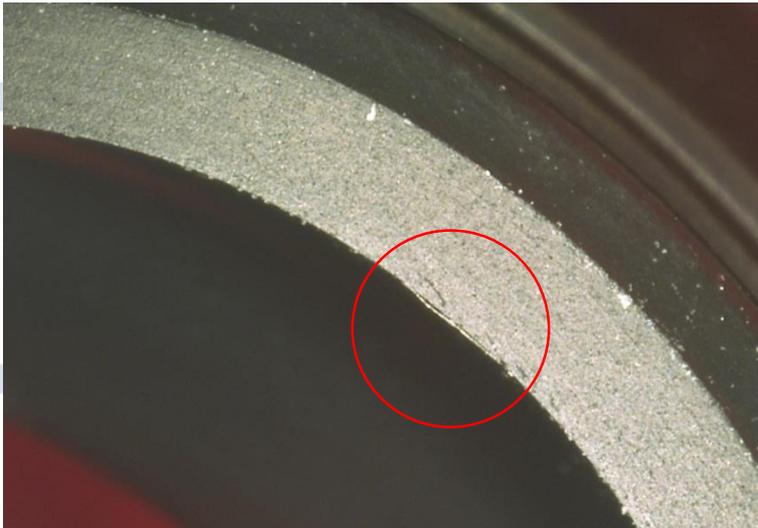
Fig. 17: Cracking caused by the finishing step "cutting off the sealing edge"

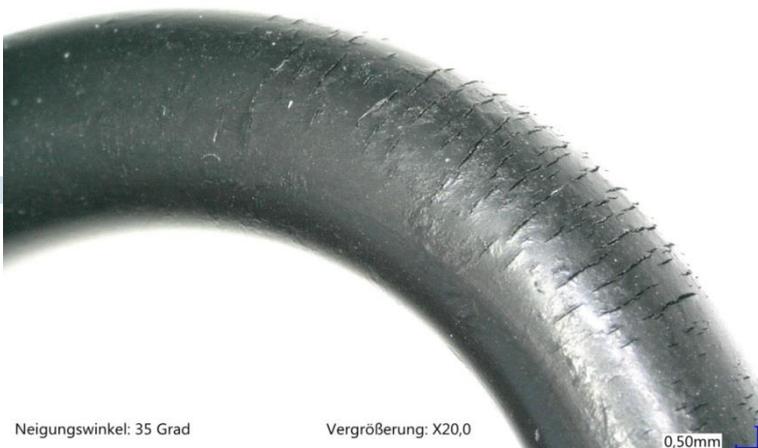
Fig. 18: Cracks caused by the post-processing step "post-curing" (local overheating due to defective or incorrectly set tempering furnace)

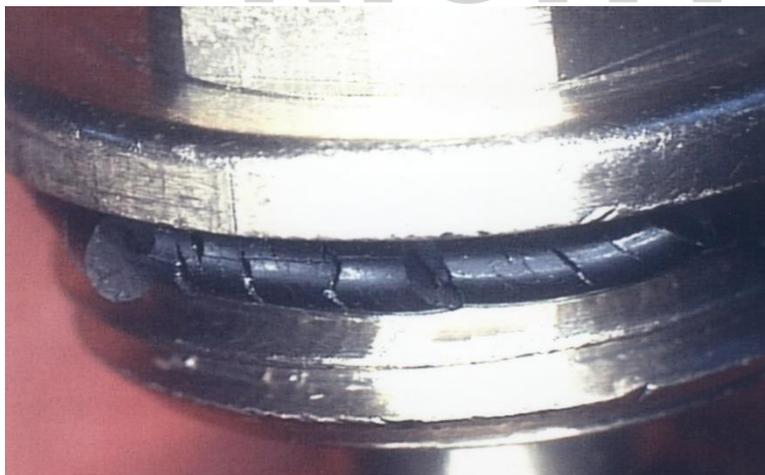
In order for ozone cracks to form, the seal must be stretched (see **Fig. 19**). Even small elongations of 5% are sufficient. With increasing elongation, the number of cracks also increases.

Fig. 19: Pre-assembled O-ring, which showed ozone cracks after several weeks due to the pre-stressing and ozone from the ambient air.

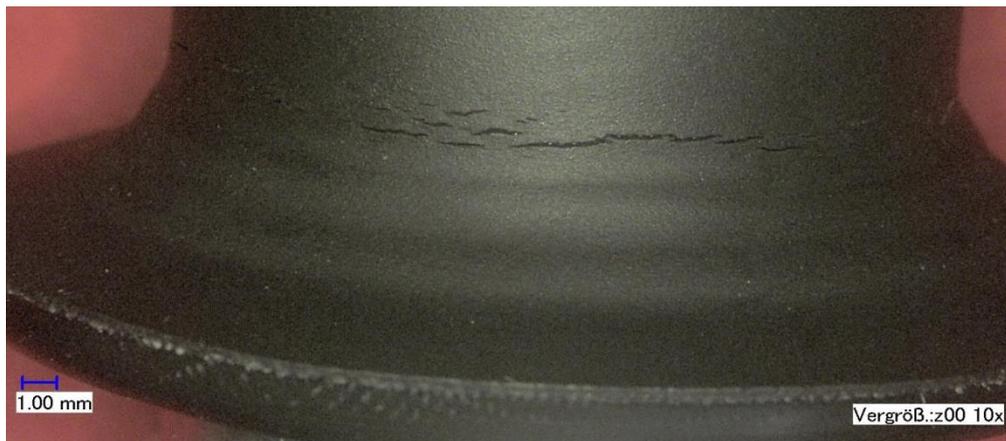
Fig. 20: Fatigue cracks on an FKM membrane

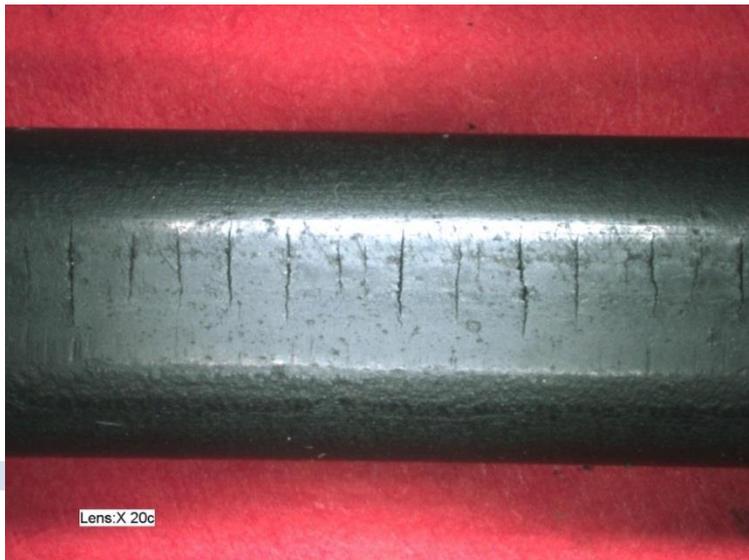
Fig. 21: Thermally damaged O-ring, fully hardened, cracks visible on the contact surfaces when bending

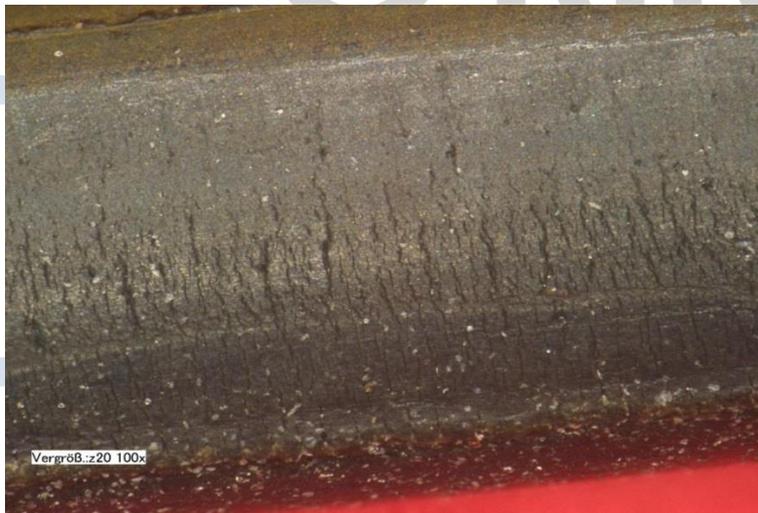
Fig. 22: Cracks due to aging due to heat and oxygen under slight elongation can be seen on the contact surface of an O-ring

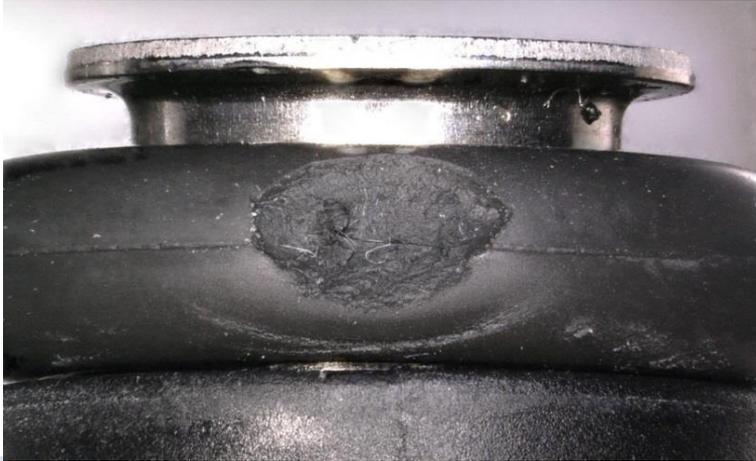
Fig. 23: Chipping out during assembly: The damage occurred at room temperature and resulted in a non-smooth fracture surface; the characteristics of the fracture surface are also strongly dependent on the tear resistance of a material.

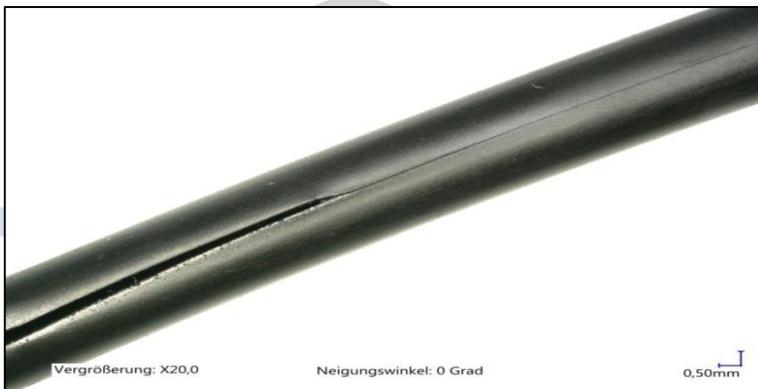
Fig. 24: Installation crack due to the impact of a sharp edge in the installation space

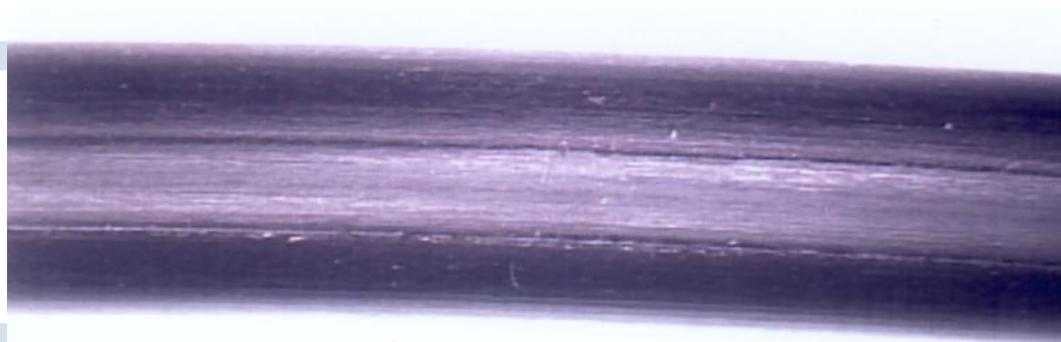
Fig. 25: Crack caused by a sharp edge during installation

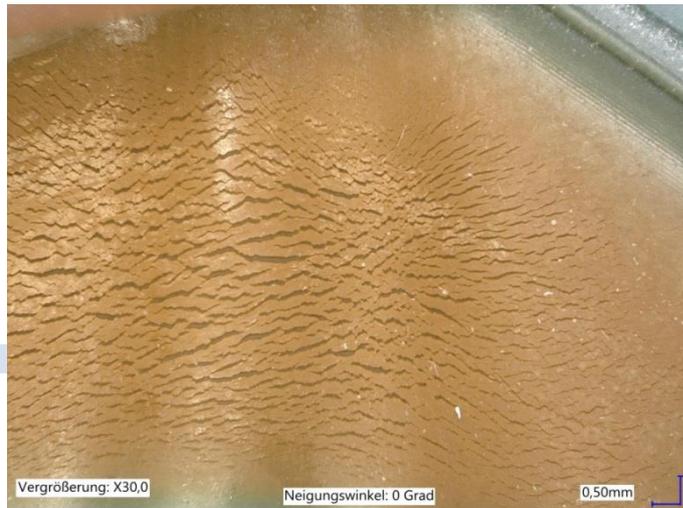
Fig. 26: Chemical degradation of an FVMQ membrane: The cracks cover a larger area.
