EXPERT KNOWLEDGE
FAILURE ANALYSIS
OF ELASTOMER COMPONENTS
SHORT VERSION

**Cracks Due to Manufacturing Problems –
Serious Defects Often Leading to Seal Failures**

Authors:
Dipl.-Ing. Bernhard Richter,
Dipl.-Ing. (FH) Ulrich Blobner

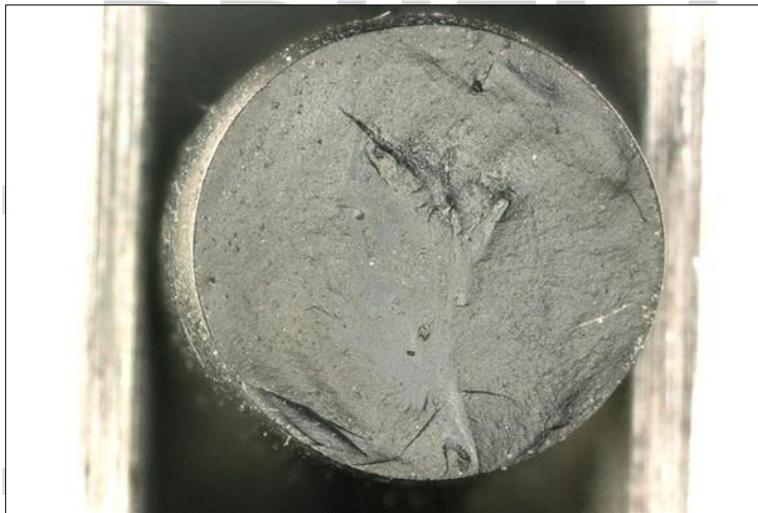
If vulcanization is faulty or a superimposed compound is used, flow lines may appear on the seal in addition to the inhomogeneous fracture surface. Cracks caused by flow lines are often parabolic and symmetrical to the parting line. In the case of faulty vulcanization, the structure of the fracture surface is usually inhomogeneous (see **Fig. 1**), in some cases there are also conspicuously smooth areas in the fracture surface. It is typical for cracks caused by vulcanization defects to have a rounded transition from the surface to the crack in comparison to a case of damage caused by cuts.

Fig. 1: Cracked O-ring caused by a vulcanization defect

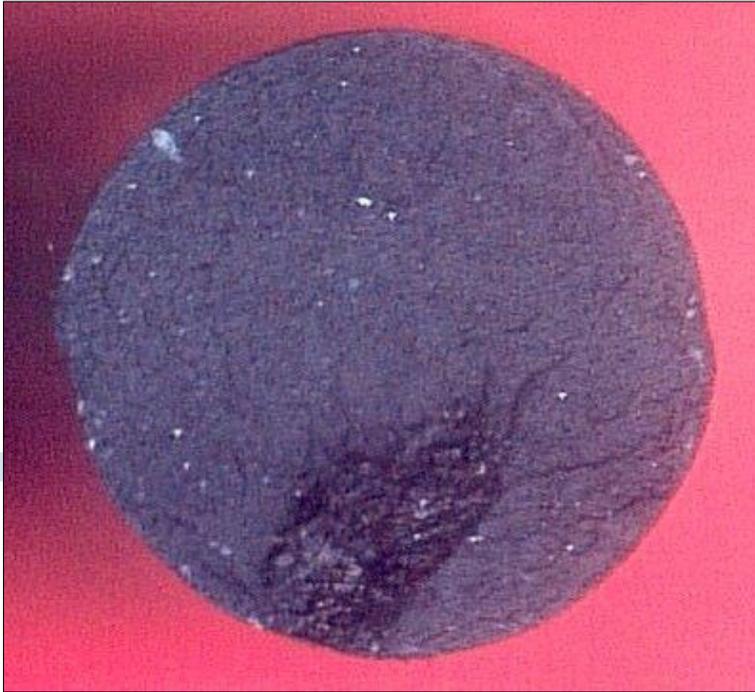
The fracture surface clearly shows the area of pollution (see **Fig. 2**) where insufficient vulcanization has occurred and the area of crack propagation (regular, slightly roughened structure, stress driven, meaning usually radial crack propagation).

Fig. 2: Crack triggered by ingress of foreign material

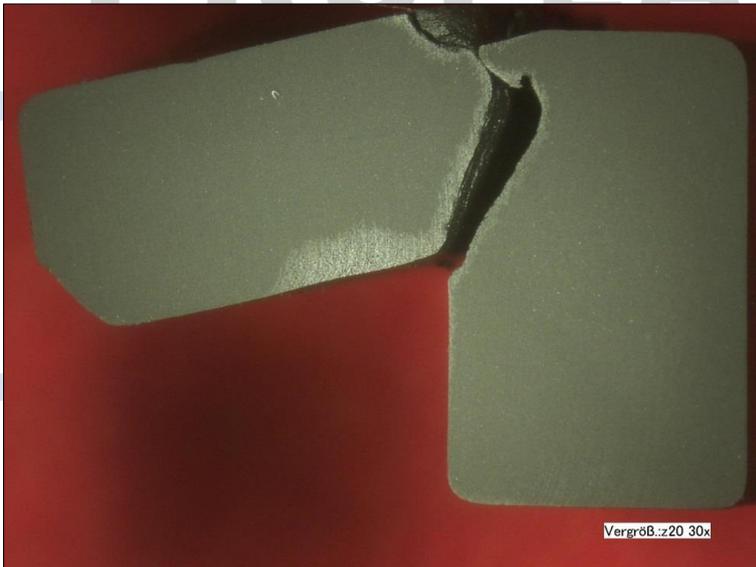
These often occur at sharp transitions, edges (see **Fig. 3**) or undercuts. Demolding cracks originate from the parting plane or another tool edge and then propagate perpendicular to the demolding stress.

Fig. 3: Demolding crack at a sealing element
