EXPERT KNOWLEDGE FAILURE ANALYSIS OF ELASTOMER COMPONENTS

Information as of 02/2018

Assembly Damages – An Often-Underestimated Cause of Damage

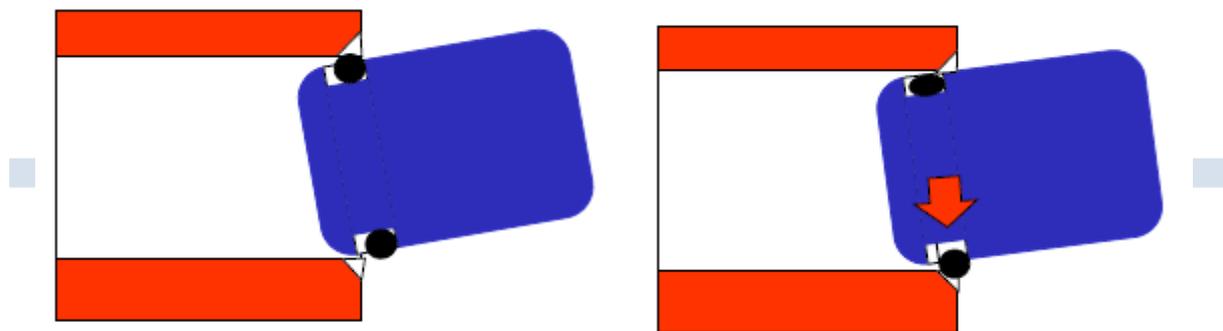
Crushing is a relatively easily recognizable assembly damage caused by incorrect positioning during assembly. The crushed areas can either remain connected to the rest of the seal or completely separated from it. They differ from operational gap extrusion strips by being significantly thicker than these. In addition, over-compressed areas can sometimes show impressions of the housing. Even if this only slightly damages the seal, the over-compressed rubber particle may be trapped between the cover and the housing that is in the main force fit. If a physical relaxation of this trapped particle occurs, in other words, if it begins to creep, the screw connection becomes loose, which can then lead to leakage. Therefore, when designing gaskets or gasket grooves, care must be taken to ensure the gasket is securely positioned between the assembly of the gasket and the joining of the two components to be sealed. Holding studs on the gasket, for example, can contribute to this. Also, special groove shapes (half or whole trapezoidal groove) can help, even if this is a more expensive option. Another form of crushing occurs when a piston part is inserted into a cylinder part and the piston part is poorly guided or can be dipped obliquely into the cylinder part (**Fig. 1**).

Fig. 1: Incorrect mounting of a piston in a cylinder: The O-ring lifts off due to the tilting in the lower area and is sheared off (Photo: O-Ring Prüflabor Richter GmbH)

The material displaced by the deformation of the seal moves in the circumferential direction, which can lead to partial lifting of the seal at the opposite point. This greatly increases the risk of assembly damage or partial shearing of the seal. If this oblique insertion of the piston cannot be avoided, e.g. by a mounting aid, the seal should be provided with a high installed internal diameter expansion. Experience shows that O-rings with approx. 70 IRHD-M with an installed inner diameter expansion of 20-25% are very robust against this damage pattern because the high elongation leads to a high deformation resistance in the circumferential direction and the displaced sealing material shifts in the axial direction.

Pistons with externally mounted seals that are to be inserted into cylinders must have a sufficiently long guide in front of the seal to prevent tilting during assembly. (see **Fig.1**)

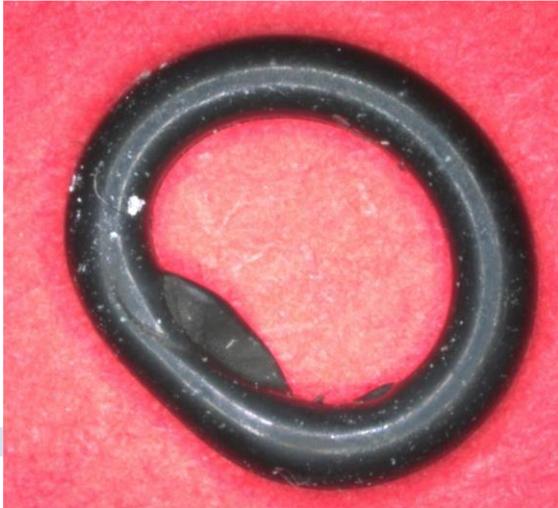
Over-compression (see **Figs. 2 and 3**) is easy to detect as assembly damage because it is caused by incorrect positioning during assembly. The over-compressed areas can either be connected to the rest of the seal or be completely separated from it. They differ from operational extrusion tags because they are thicker than normal. In addition, over-compressed areas can sometimes show impressions of the housing.

Fig. 2: Crushing due to incorrect positioning of the seal

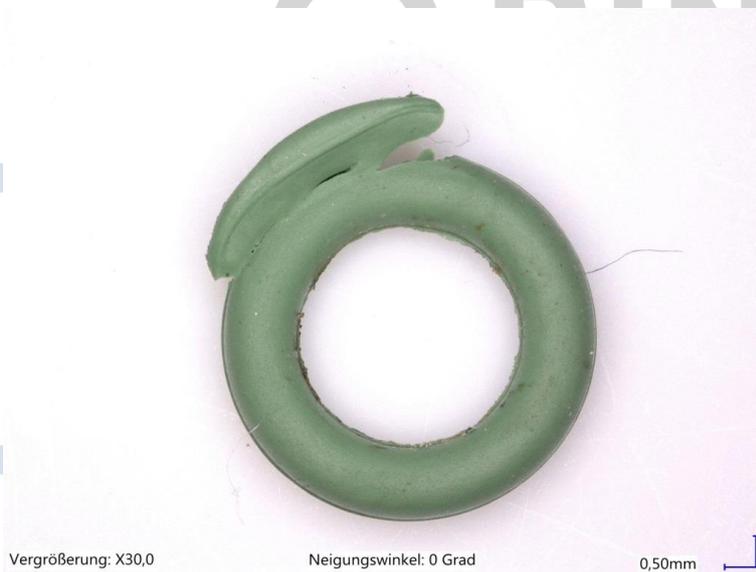
Fig. 3: O-ring with crushed area during assembly

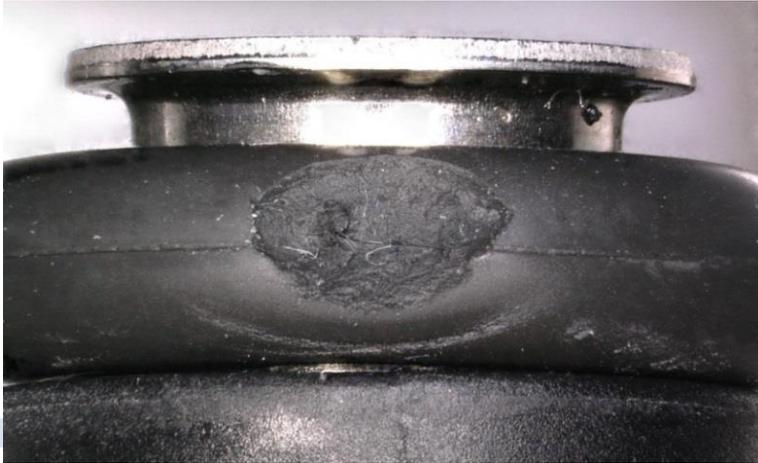
This is probably the most common assembly error. It "is usually a case of violent cracks, which have a regular, rather slightly rough fractured surface. The degree of roughness also depends on the tear resistance of the material. Fractures caused by manufacturing, on the other hand, show inhomogeneous, often relief-like raised areas in the fracture surface. The crack origin in assembly cracks shows a conspicuously linear beginning (see **Figs. 7 and 8**), and there is also no rounded transition from the surface to the crack in the case of damage caused by sharp-edged assembly spaces. Slightly rounded edges show an impression and/or slight plastic deformation.

Fig. 4: Material chipping caused by assembly:

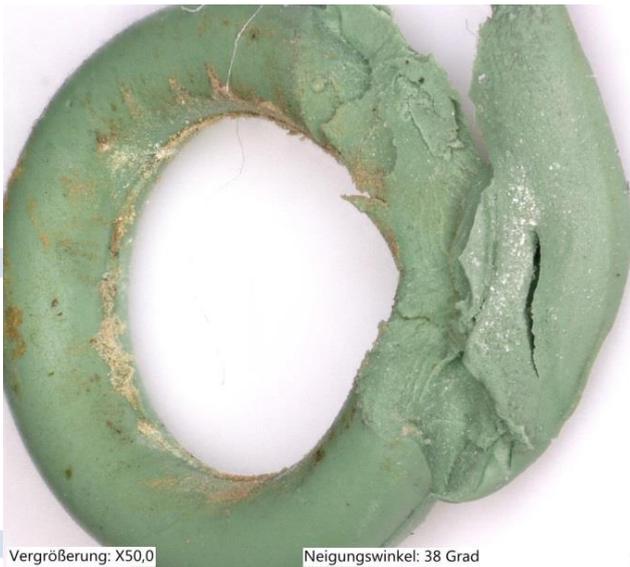
Fig. 5: Part of an O-ring sheared off by assembly

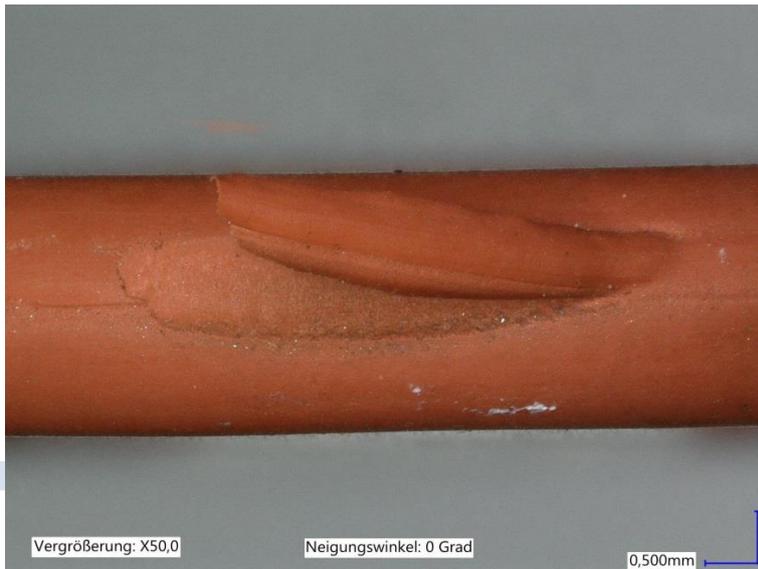
Fig. 6: Shearing off during non-centric insertion due to a local accumulation of material

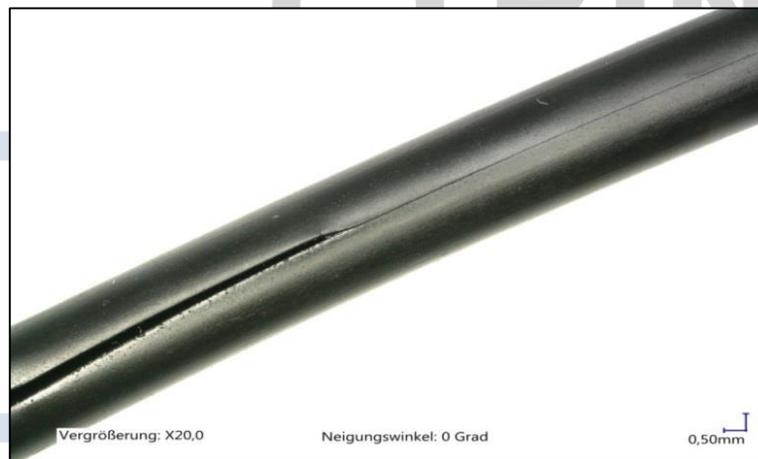
Since rubber seals have to be deformed considerably during the assembly process, the high assembly forces required for this can lead to considerable line pressures at the edges of the assembly space, especially if the assembly is not lubricated. If these edges are not neatly rounded or chamfered, this can already lead to a cut during assembly, see **Fig. 7**.

Fig. 7: Assembly-related crack due to the impact of a sharp edge in the installation space

The lead-in chamfers should be between 15° and 20°. Sharp edges and transitions must be removed. This should also be explicitly noted in the drawing.

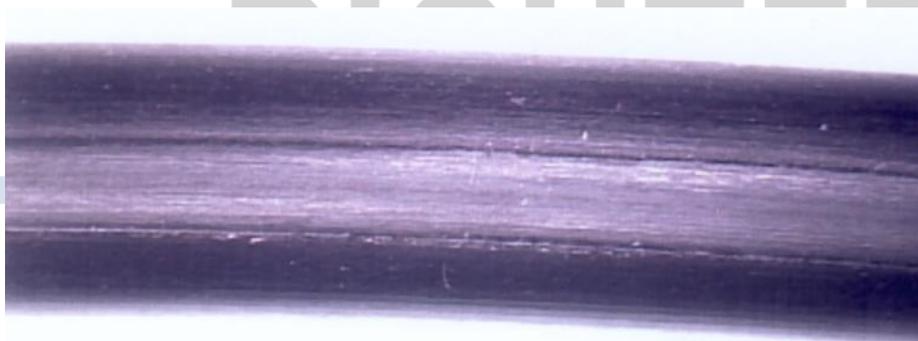
Fig. 8: Crack caused by a sharp edge during assembly

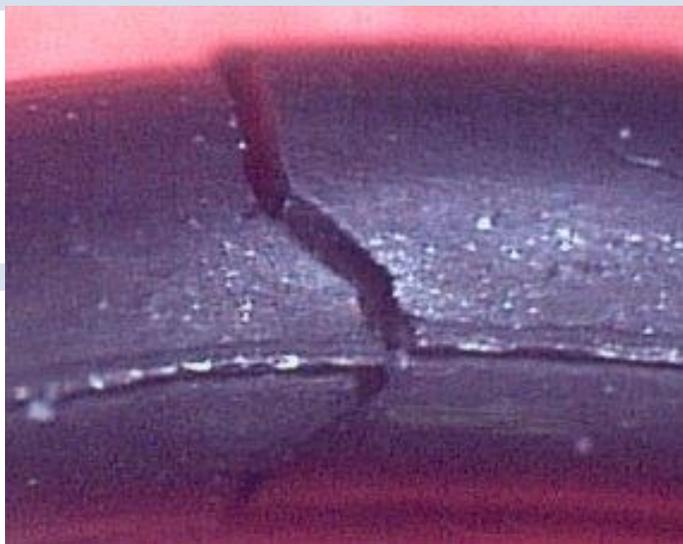
Cracks resulting from flow lines are often parabolic and symmetrical to the parting line (see **Fig. 9**). If vulcanization is faulty, an inhomogeneous fracture surface is usually visible (see **Fig. 10**). Sometimes conspicuously smooth areas can also be found in the fracture surface. A rounded transition from the surface to the crack (see **Fig. 11**) is also typical for damage caused by vulcanization defects, compared to a case of damage caused by a cut."⁹

Fig. 9: Manufacturing crack, parabolic and symmetrical to the mold parting line

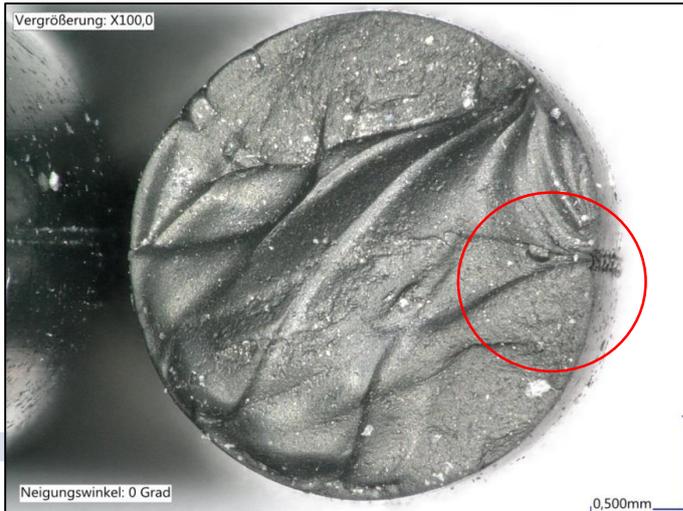
Fig. 10: Ruptured O-ring due to vulcanization defect: Inhomogeneous and fissured fracture surface

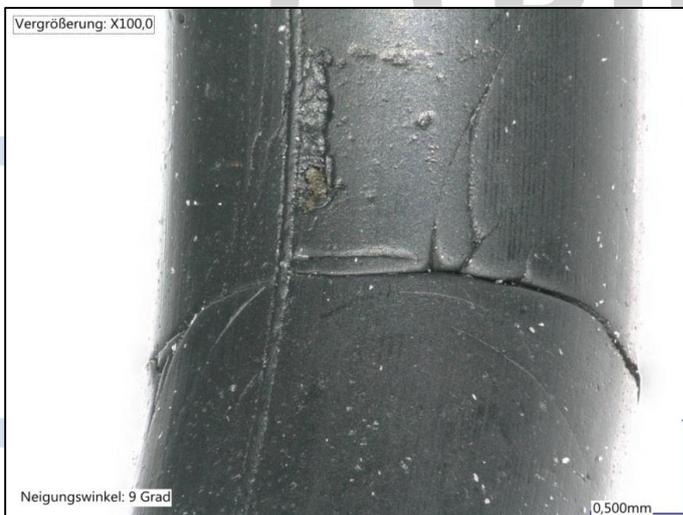
Fig. 11: Vulcanization defects due to manufacturing: Rounded crack transition
