EXPERT KNOWLEDGE
FAILURE ANALYSIS
OF ELASTOMER COMPONENTS
SHORT VERSION

**Assembly Damages –
An Often-Underestimated Cause of Damage**

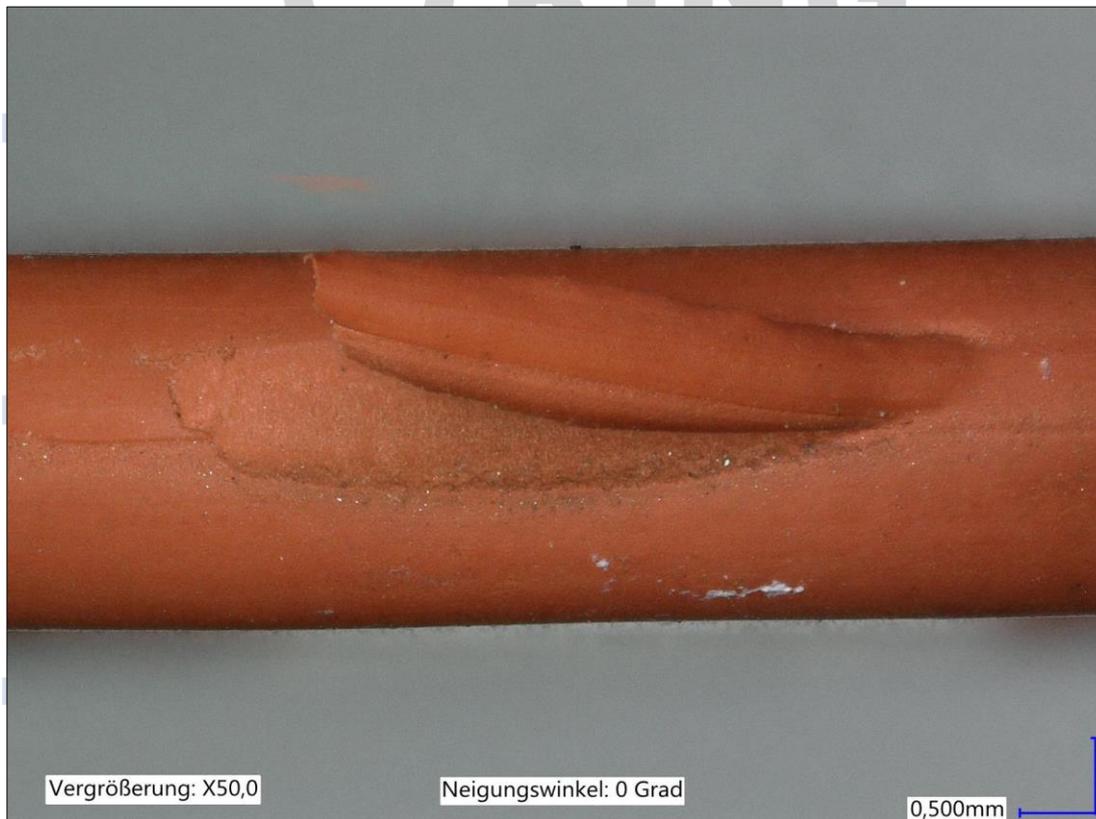
If a piston part is not guided when it is inserted into the cylinder part, there is danger that the oblique insertion will displace the sealing material and move it in a circumferential direction (instead of in an axial direction). In this case, material accumulates in the area not yet inserted and the seal is lifted out of the groove. During automatic assembly or during "dynamic" manual assembly, some material may be sheared off at the outer diameter when this side is inserted (see **Fig. 1**).

Fig.1: Material shearing due to non-centric insertion of a piston

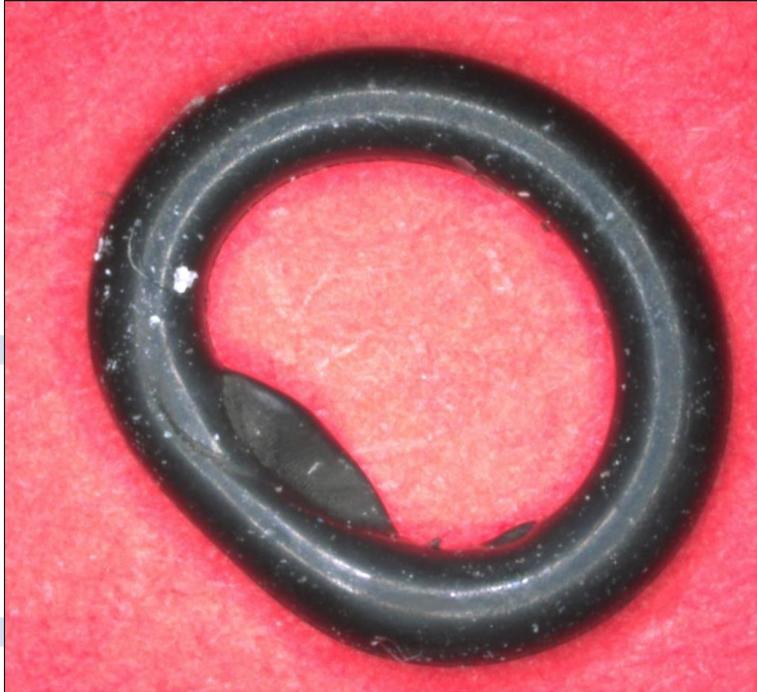
Over-compression (see **Fig. 2**) is relatively easy to recognize as assembly damage because it's caused by incorrect positioning during assembly. The over-compressed areas can either be connected to the rest of the seal or completely separated from it. They differ from

operational gap extrusion tags in that they are significantly thicker than these. In addition, over-compressed areas can sometimes show impressions of the housing.

Fig. 2: Crushed due to incorrect positioning of the seal

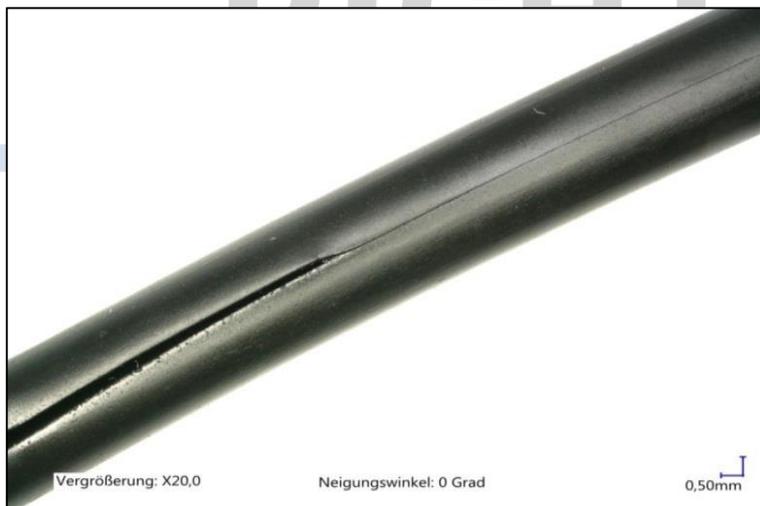
Since rubber seals have to be deformed considerably during the assembly process, the high assembly forces required can lead to high line pressures at the edges when mounting, especially when not lubricated. If these edges are not cleanly rounded or chamfered, this can lead to a cut during assembly (see **Fig. 3**).

Fig. 3: Installation-related crack due to the effect of a sharp edge in the installation space

In order to avoid assembly errors with O-rings, see ISO 3601-2, for more information on the design of insertion chamfers and edge radii. These specifications may also apply to other seals as guide values. In addition, it is advisable to study manufacturer information and attend specialist seminars.
