O-ring failure: The true causes

An evaluation of more than 500 failure analyses

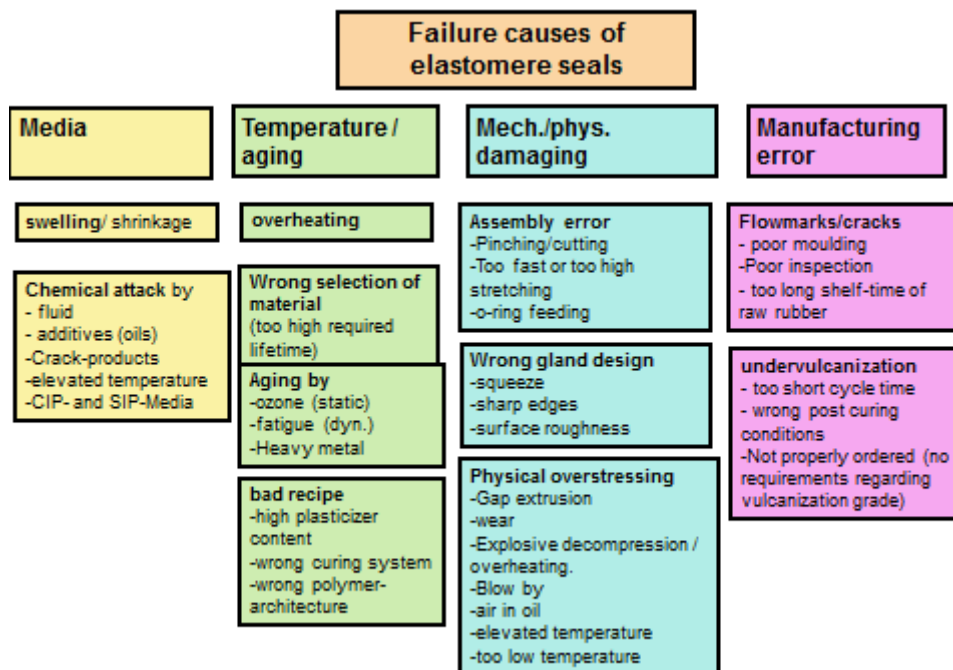
Figure 1 – Classification of the failure causes

The classification of failure mechanisms in four different classes has proven to be useful (**Fig. 1**):

Medium

Damages by either a strong swelling (strong shrinkage in some special cases) or chemical effects like loss of elasticity, significant cracks and/or strong permanent deformation.

Temperature/Ageing

Damages by either a strong overheating, high above the acceptable permanent temperature limit what leads to a surface damaging (crack formation in general), or by a brittleness combined with a permanent deformation for an application within the polymers' temperature limits due to a too long operating time (polymer doesn't fit the application, e.g. NBR in hot water) or the usage of a not state-of-the-art recipe (sulfur cured EPDM instead of peroxide cured EPDM). This class also implies damage mechanisms that lead to an early failure due to

Mechanical/Physical effects

This class includes all failure causes that are able to explain the failure without any changes in the network structure of the material but doesn't imply any manufacturing defects. The word mechanical should highlight that this class also contains damages that occur during assembly. Additional typical causes are sharp-edged clearances or a too high deformation, gap extrusion, abrasion or explosive decompression.

Manufacturing defects

Manufacturing defects are defects that result from the manufacturing process and represent an unacceptable deviation from the target state. As far as form and surface deviations are concerned, the acceptable error range is clearly regulated by ISO 3601/part 3. Thereby, radial flowmarks and incipient cracks are the most common defects to appear. Undercuring is a serious manufacturing defect too, binding specifications for finished parts, however, do only exist in some special cases. Therefore, there are no nominal values in most cases, and even if those values exist it can be very hard to prove an undercuring after failure.

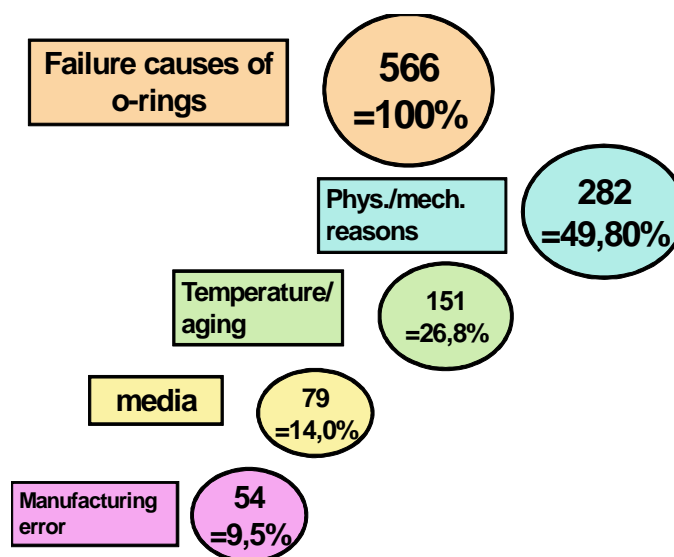
Figure 2 – distribution of failure causes

566 failure analyses of O-ring seals result in a distribution according to **Fig.2**, regarding the different failure causes described above. It should be mentioned that in some cases a combination of different causes lead to a failure. Those failures were classified regarding the dominating failure cause. Furthermore, it should be clear that indications are being analyzed, as no “eyewitnesses” are existant. As a result it may happen that in some particular cases, despite of all acurateness and a common belief in ones own competences, indications aren’t evalueted correctly, especially if there is a lack of information concerning the failure conditions. It is remarkable that the distribution of failure causes after 110 (1st evaluation) and after 180 (2nd evaluation) failure analyses, was almost similar to the distribution after 566 analyses (**Fig.2**). This fact can be seen as an indicator for a good representation of reality.

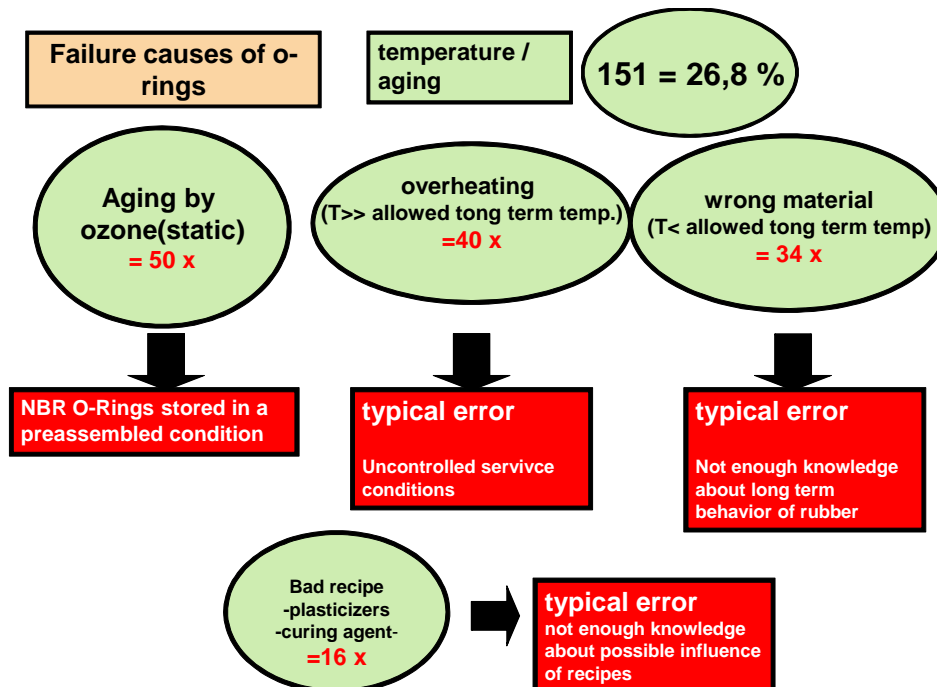
Figure 4 – failure causes due to ageing (heat and oxygen)

Ageing is defined as a change in the chemical and/or physical properties of a material during storage or usage. This evaluation doesn't include the influence of the sealed media; therefore the failure causes summarized in this group are reduced to the effects of heat and oxygen (**Fig. 4**).

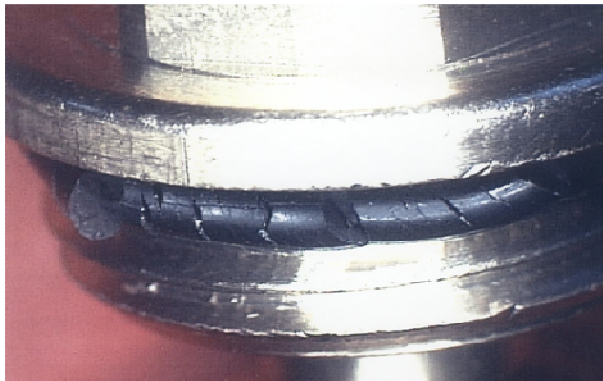
Figure 5 – failure cause: ozone cracks

Fig.5 shows the damage symptoms of a failure due to “ozone cracks”. Ozone cracks occur frequently at pre-assembled NBR O-rings that are exposed to ozoniferous ambient air without protection over a long period of time (at least several days).

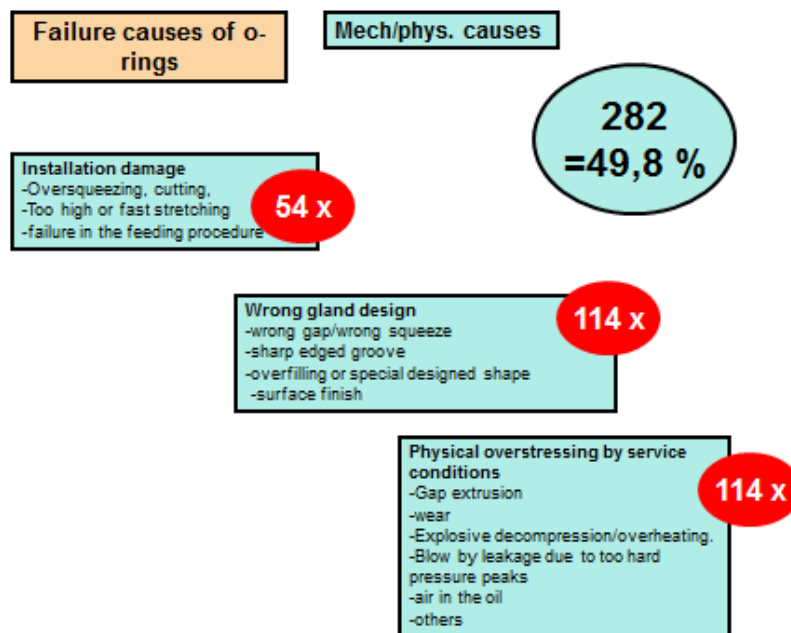
Figure 7 – Failure causes due to physical/mechanical effects

This group summarizes all failure causes that are able to give an explanation of the failure without any changes in the network structure of the material but doesn't imply any manufacturing defects. A remarkable fact, regarding **Fig.7** is that a lot of failures don't occur due to common causes like gap extrusion, abrasion or explosive decompression, in fact a lot of O-rings fail due to less spectacular reasons like assembly faults or wrong clearance design. This verifies the fact that a majority of design engineers doesn't pay enough attention to the design and the dimensioning of O-ring seals. Therefore, there is a need for action, in particular to qualify and sensitize the design and production engineers to this topic, in order to attach higher value to the field of O-ring seals.

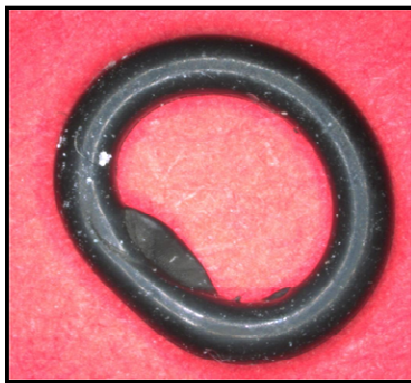
Figure 8 – installation damage

Fig. 8 and 9 show typical examples of assembly faults that usually occur due to a bad design of the inlet and/or a lack of lubrication. Surprisingly high, namely 20.1%, is the rate of failures due to bad design and dimensioning of the clearance. That implies sharp edges, less or too much deformation, an overfilling of the clearance, clearance of diameter or poor surface quality (**Fig.10**). Only after that failure causes like gap extrusion, abrasion (**Fig.11**) and explosive decompression/explosive overheating come into play. Less well-known failure causes like dynamic caused overflowing (blow-by effect) or air in the oil [E1] are worth a mentioning too.
