Why O-Rings Fail

Several O-Ring modes for O-Rings and their causes

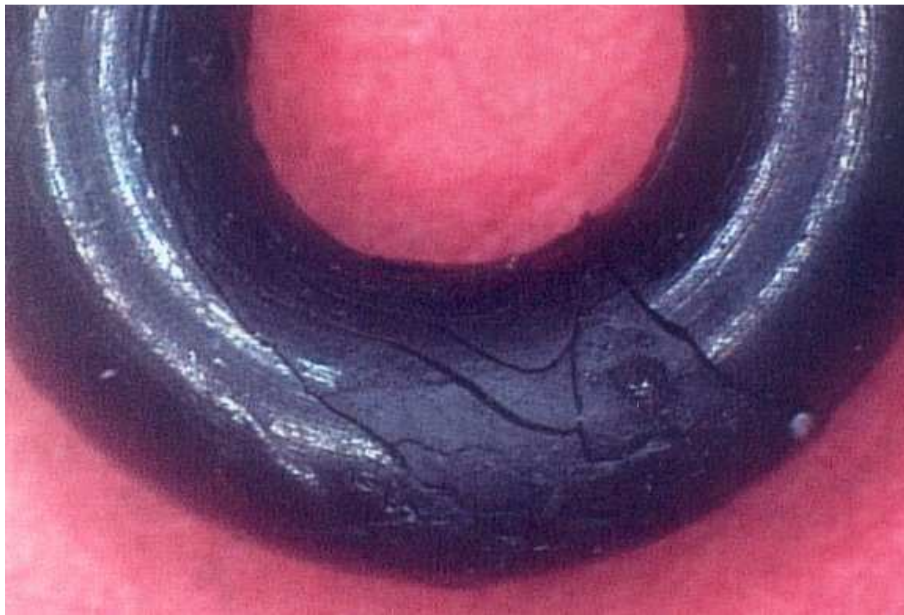
Photo 1: Extreme flow lines; during injection if mold flow runners are too long or mold temperature too high, the material scorches.

An O-Ring manufacturing operation faces such strong cost pressures that during vulcanization, as in molding of O-Rings, processes are often at the limit of what is doable. It follows that one expects a certain quantity of O-Rings will not meet the form and surface quality requirements of the end user. For this reason a final inspection, in which defective parts are sorted good from bad, is an important part of the manufacturing process. Various methods are used, from sampling plans, to belt and table inspection, to automated vision inspection machines. A differentiating characteristic between a good and poor O-Ring supplier is thus the type and quantity of defective parts that finally reach the end user. Photo's 1 and 2 show two extreme manufacturing defects.

As effective control measure it is recommended that a consistent sample inspection for surface defects be implemented at incoming inspection.

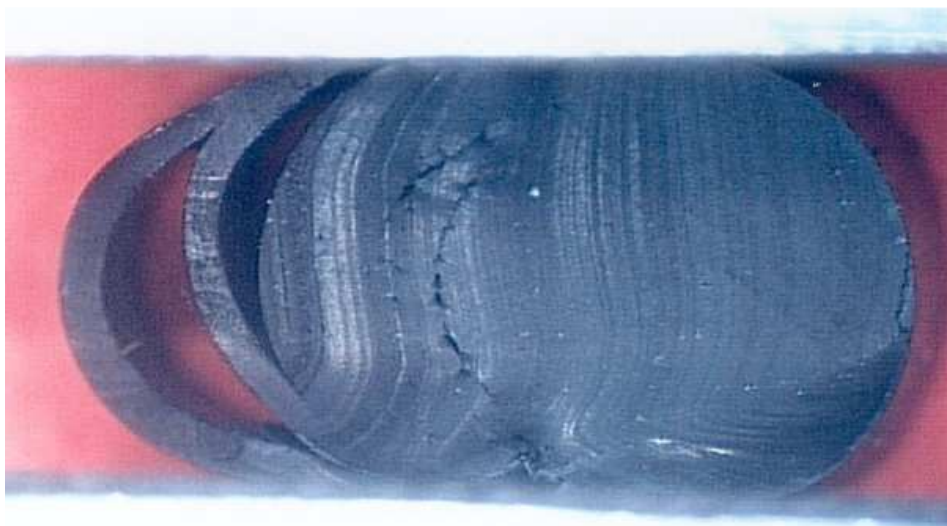
Photo 2: Internal splits, that propagate through the O-Ring during service. The probable cause most likely the use of scorched material (expired shelf life).

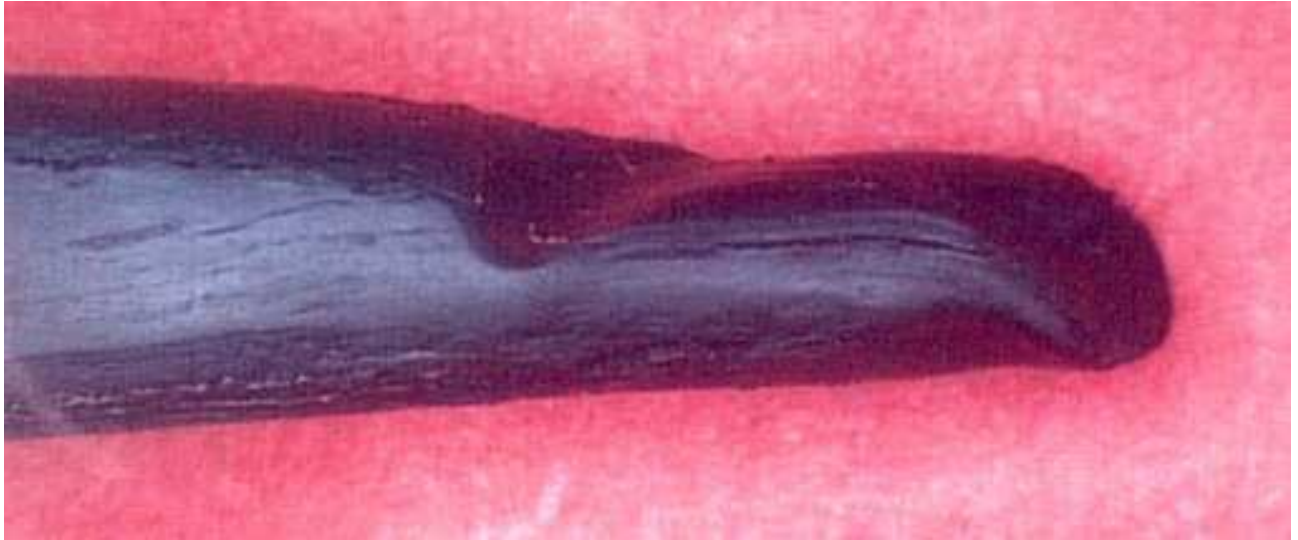
O-Rings that come in contact with sharp edges can be damaged and can lead to subsequent failure. This damage can occur not only in the gland area when crossing over counter bores or channels, Photo 3, (another frequent problem are sharp

Photo 3: Sheared o-ring from passing over flow channel during assembly.

Avoid assembly defects through careful design of gland and O-Ring lead-in guide chamfers. Reducing assembly friction of O-Rings greatly reduces assembly risk as well. Related is the flatness and roundness of o-rings (minimal „ potato chip“ and ovality); allowable tolerances should be agreed upon with the O-Ring supplier. With

regards to O-Ring physical properties, especially elongation, minimum requirements should be defined.

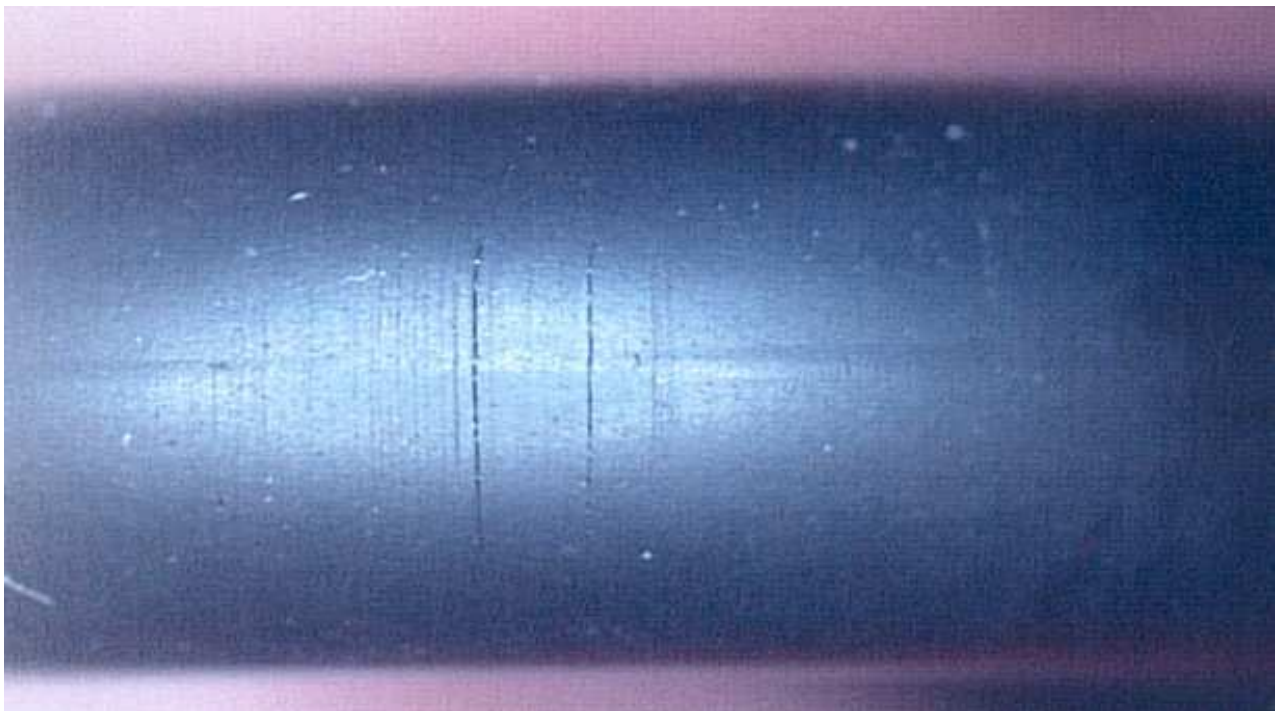
groove edges and burrs), but also on the lead-in chamfer (Photo 4), or picking/grabbing of automatic O-Ring assembly equipment. During automated assembly operations, extremely fast stretching of parts can cause tears; just as immediate subsequent insertion does not always allow adequate time for the o-ring to recover from stretching and can be sheared.

Photo 4: O-Ring damage from passing over guide chamfer.

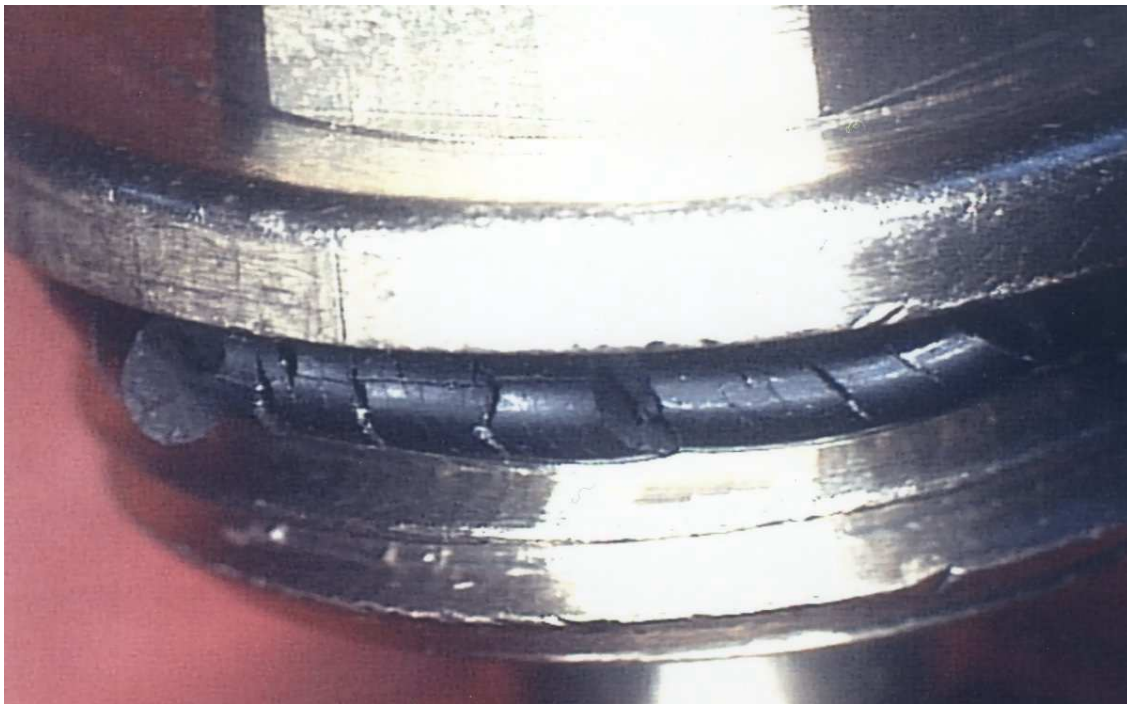
One should be careful when using NBR o-rings in environments where o-rings assembled on sub-components that are temporary stored prior to final assembly; exposure to air and weather can cause ozone cracks even after a short period of time, see Photo 5. This requires that pre-assembled NBR o-rings in temporary storage for more than several hours be protected from air and direct light. If this is not possible it is recommended that as minimum, an NBR recipe with improved ozone resistance be used, otherwise an ozone resistant elastomer such as EPDM or FKM be used.

Photo 5: Ozone splits on an assembled o-ring on sub component following several weeks in storage without light and air protection.

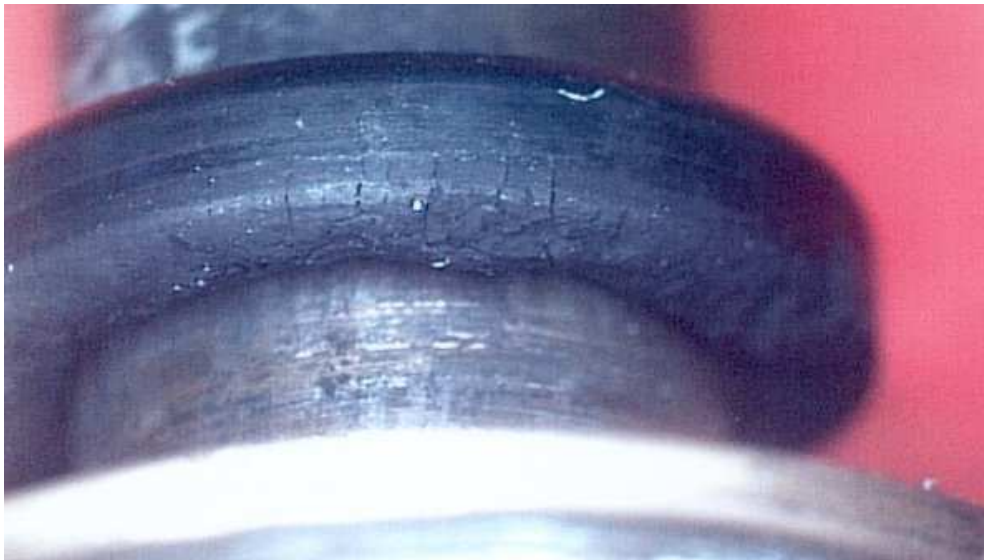
Excessive O-Ring temperature exposure can occur in two different forms. A short yet excessively high exposure temperature can cause surface cracks on the o-ring without the O-Ring actually getting brittle. The other form follows from long term exces-

sive thermal exposure which result in splits and ruptures, brittleness and permanent deformation, see Photo 6. These splits that develop due temperature generally occur on the contact surface (flattened side), while chemical attack occurs on surface exposed to the fluid (round side).

Photo 6: NBR O-Ring after excessive thermal exposure, with severe cracking and flattening.

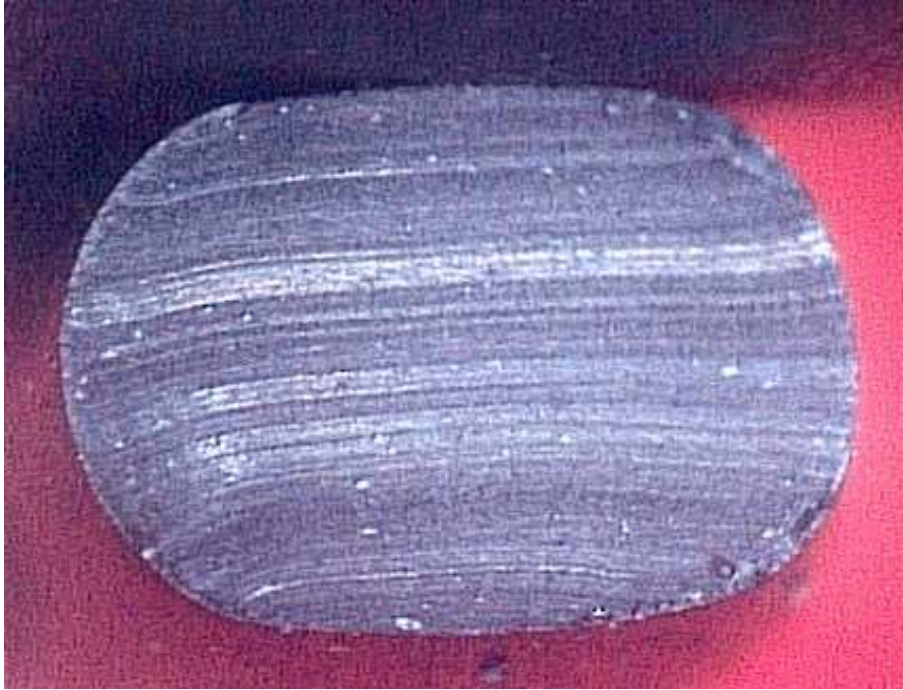
Often underestimated are the influences of formulation and process quality of O-Rings. If O-Rings are of a poor quality formulation (ie high plasticizer content) or poorly vulcanized, severe compression set can result in just a few weeks or months, Photo 7. As a preventive measure, a compression set specification for production O-Rings should be established, as merely providing a data sheet for the material is not adequate assurance that O-Rings are properly vulcanized. Additional procurement requirements are naturally prudent as they relate to ensuring good vulcanization practices and material quality.

Photo 7: Permanently deformed O-Ring.

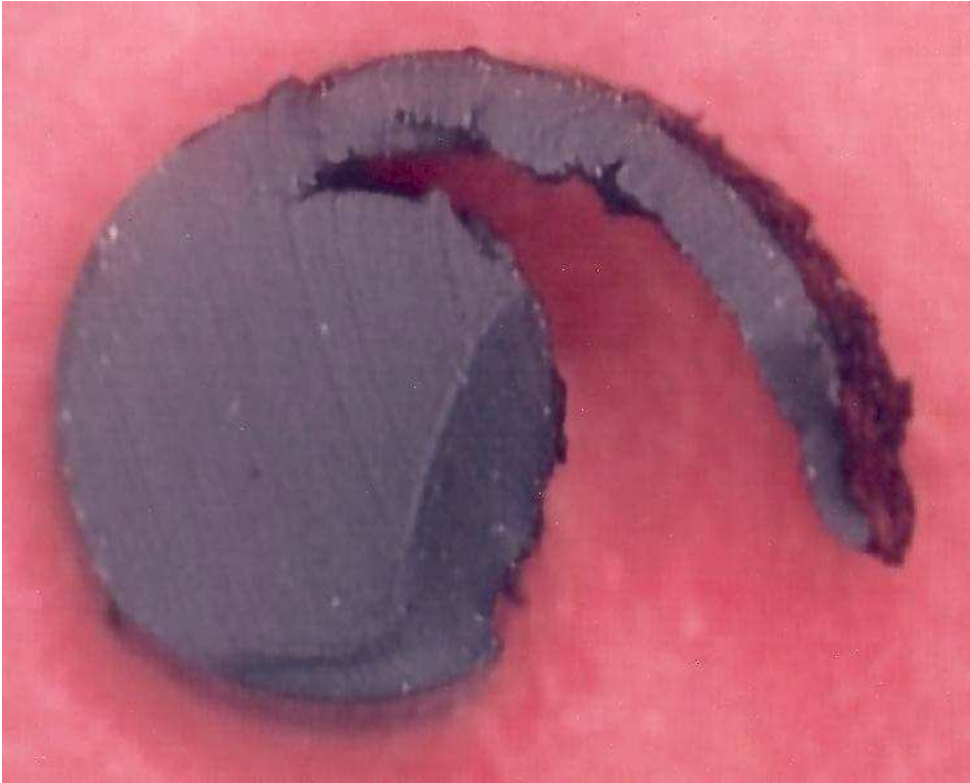
This is possible when recommended sealing gap limits are not exceeded for a given O-Ring durometer hardness. If these precautions are not followed the O-Ring will extrude into the seal gap, see Photo 8. The result is known to most designers. What is often missed is the impact of the groove edges. If these edges are not adequately rounded the O-Ring can become damaged even with relatively small seal gaps, see Photos 9 and 10. The O-ring in Photo 9 was used in a stack valve at 250 bar in which the outside diameter groove corners were sharp. Photo 10 shows an O-Ring taken from a water valve; the O-Ring was destroyed by a the sharp edge of a backup ring. It is especially recommended that for sealing of high pulsating pressures particular attention be given to the rounding of groove edges. When using backup rings, avoid those with sharp edges.

Photo 8: Extruded O-Ring (excessive seal gap)

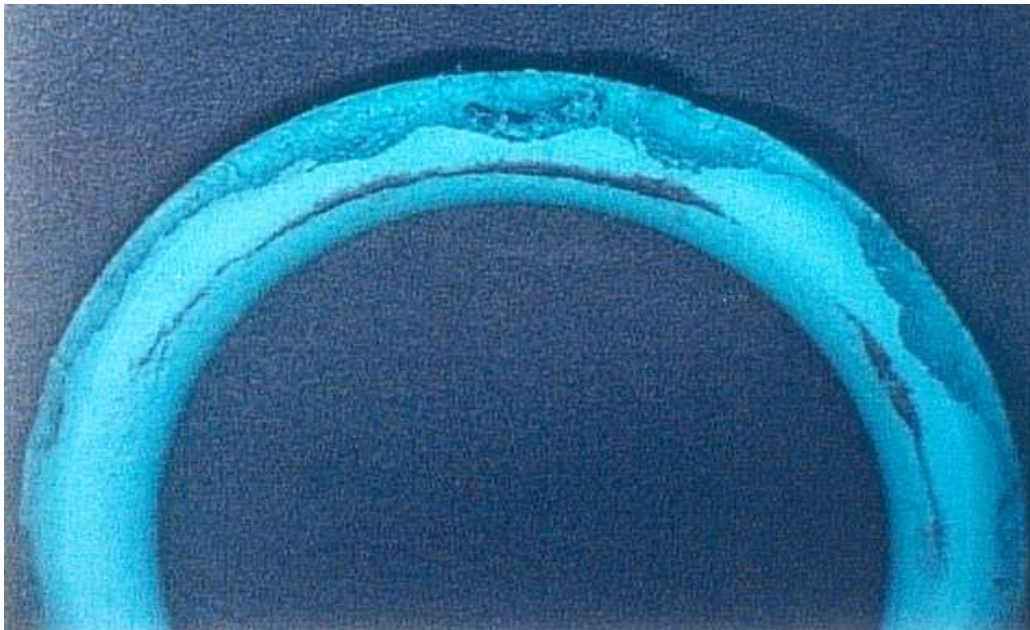
Photo 9: Damaged O-Ring resulting from sharp corners and high pressures (ca. 250 bar).

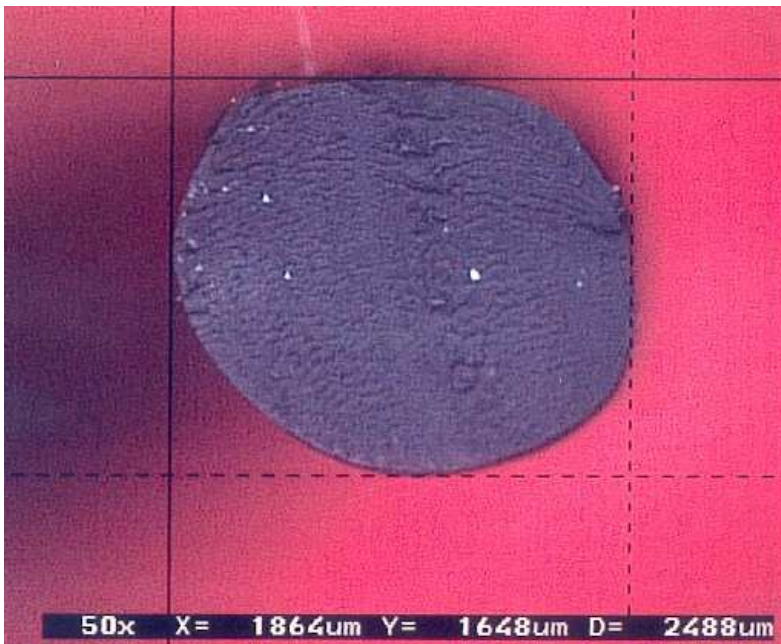
Next it must be noted that O-Rings are seldom the best technical solution for dynamic seals, while for static applications they are very capable. Greater wear compared to lip seals and less admissible gaps as examples. But even in static applications, a poorly machined gland can yield failures characteristic of dynamic seals, namely extreme flattening through abrasion, see Photo 11. At high pulsating pressures (>200 bar) even the small relative movement of a few tenths of millimeter against a poorly finished mating surface is enough to cause extreme abrasive flattening. This relative movement can result from poor stiffness of mating components, poorly constructed joints, or excessively wide finish tolerances.

Photo 11: Single abraided flat surface on O-Ring (static seal)

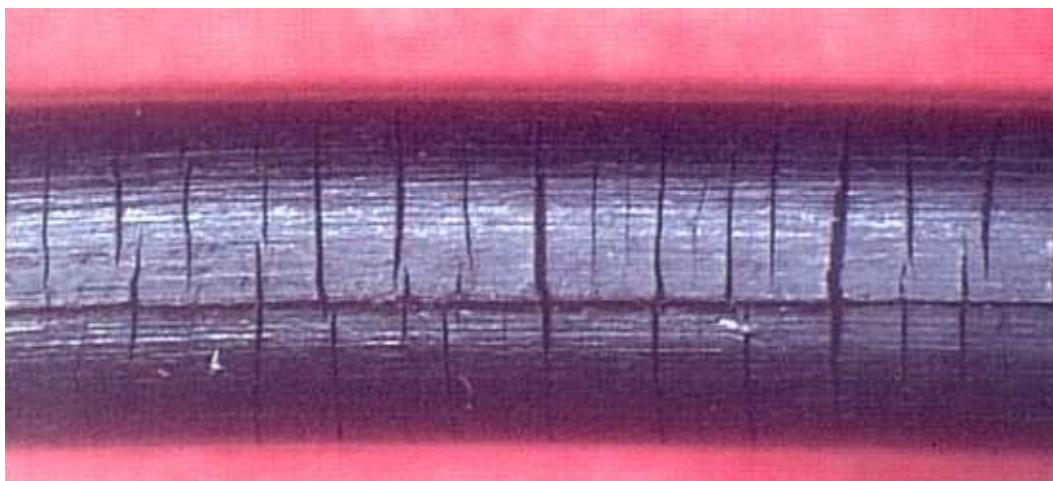
Chemical incompatibility with the product or a cleaning/ sterilization media results in the loss of elasticity and often to the formation of cracks, Photo 12. Not seldom the cause for this is the selection of a material without considering all possible fluids that can come in contact with the O-Ring. Also inadequate immersion testing prior to material selection can be the reason for chemical compatibility problems, particularly when the effects of specific additives are not properly evaluated; as an example Standard FKM elastomers in highly additivated transmission oils.

Photo 12: Splits on the fluid side are typical characteristics of chemical attack.

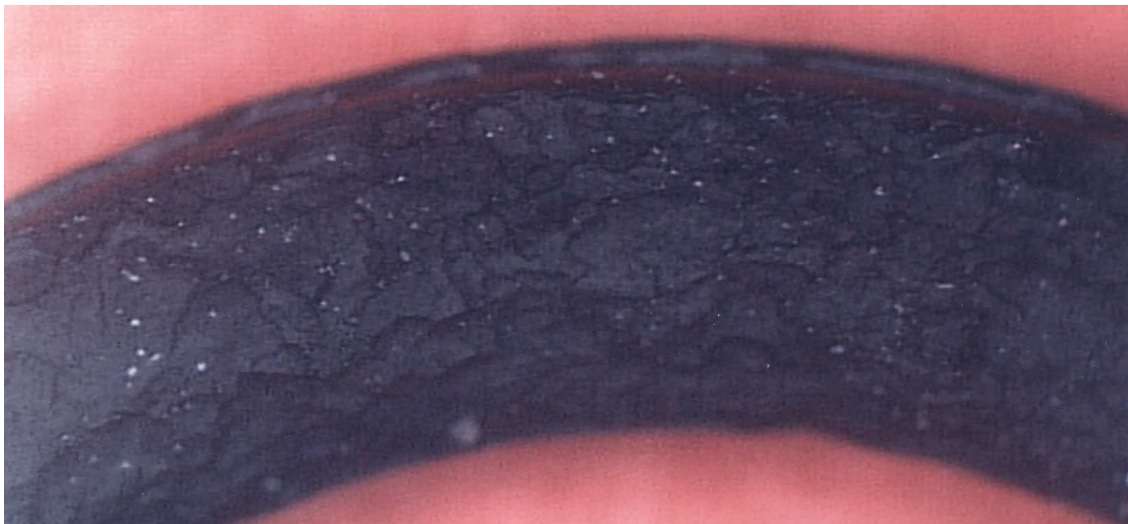
Mineral oils under increasing pressure dissolve increasing amounts of air that can expand in an explosive manner very quickly upon sudden pressure drops, resulting every so often in damage to the O-Ring, Photo 13. Unlike extrusion, the damage occurs on the pressure side of the O-Ring.

Photo 13: Damage from explosive decompression of air.
