FAILURE ANALYSIS

OF ELASTOMER COMPONENTS

Thermal Overloading – Temperature Alone is Rarely the Problem, It's the Wrong Combination of Temperature and Time

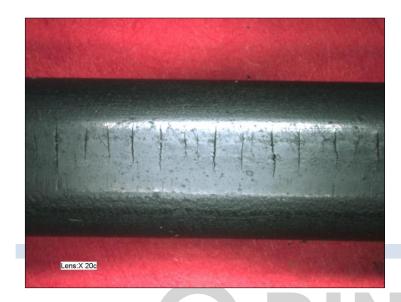
Fig. 1: Thermally damaged O-ring, completely hardened, cracks visible on contact surfaces during bending

In the event of thermal overloading over long periods of time, the O-ring or seal becomes brittle over the entire cross-section. When bending, the cracks appear preferably on the air side or on the sealing surfaces where the heat was applied.

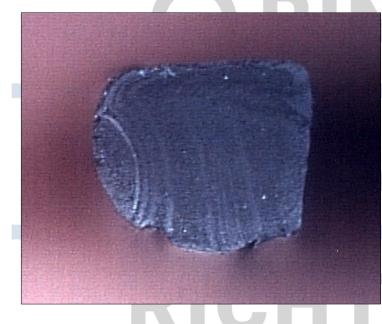
Fig. 2: Cross-section of a heavily overheated O-ring (short operating time) due to dry start-up of a mechanical seal, permanent deformation and only local embrittlement are noticeable, the core is still fully elastic.

Short periods of severe overheating lead to fine deep cracks (scaling or embrittlement only at the edges), which only appear when the seals are pulled or bent, without the seal becoming brittle as a whole. Due to the short period of loading and the insulating effect of the rubber material, the excessive temperature cannot yet visibly damage the inner area.

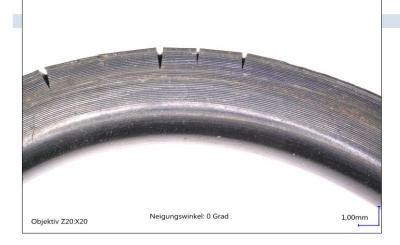
Fig. 3: This brittle NBR O-ring shows cracks during bending (circumferential grooves are an impression of the contact surface), differentiation from ozone cracks: Hardening of cracked zones. In the case of ozone or fatigue cracks, there are cracks in the elastomer matrix, which is still elastic here.

EPDM compounds, whose base polymer consists only of carbon and hydrogen, usually show a sooty surface after overheating, which slightly stains when rubbed with the finger. Seals made of NBR rubber have a glossy surface after thermal overloading, whereas FKM elastomers bond with the mostly metal counter surface.
