EXPERT KNOWLEDGE FAILURE ANALYSIS OF ELASTOMER COMPONENTS

Chemical Erosion and Swelling Destruction of Network Structure by Contact Medium

Authors: Dipl.-Ing. Bernhard Richter, Dipl.-Ing. (FH) Ulrich Blobner

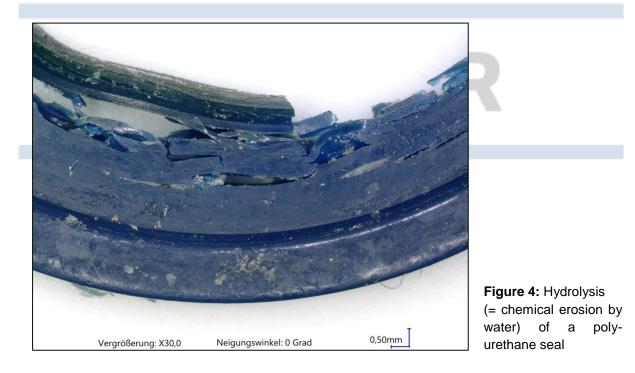
The following points are evidence that a chemical erosion has happened (see Figures 1-5):

- Cracks towards the medium, which are visible to the naked eye or only under the microscope in a stretched condition. These can already occur before the material loses its elasticity.
- Strong setting behavior of the seal
- Sticky surface and strong softening (polymer degradation), to some extent also sooty surface

Hardening and loss of elasticity, i.e. breaking of the seal after light bending or tensile stress

Figure	3
Vergrößerung: X30,0	Neigungswinkel: 0 Grad	0,50mm erosio blow-b	ra

Figure 5: Chemical erosion on FVMQmembrane probably by blow-by-gas in engine oil

Through chemical erosion, polymer degradation and thus softening can occur. Thereby the risk of gap extrusion increases and the resilience of the seal decreases significantly. Or the attack leads to a hardening and finally to the rupture of the seal which causes a failure of the sealing system. Frequently the compression set is a side effect of a chemical erosion which in the end leads to leakage.

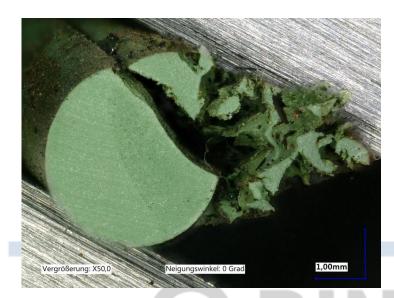
Figure 6: Strong swelling which resulted in shear

The following points are evidence that swelling as cause of failure has taken place (see **Figure** 6 and 7):

- The seal still behaves typically elastic
- Material disruptions or one or two-sided extrusion flash
- Significant increase of volume which usually leads to decrease of density and hardness and increase of the cross-sectional area
- A comparison with a new (unused) seal in a thermogravimetric analysis (TGA) reveals a significantly higher amount of vaporisable respectively extractable components

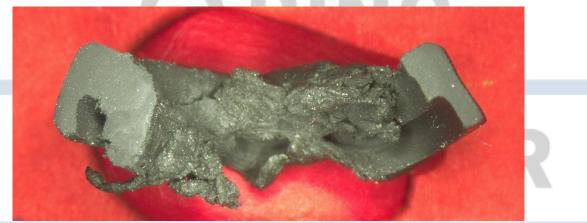
Figure 7: Strongly swelled EPDM-seal after dynamic stress of a lip seal
