# EXPERT KNOWLEDGE FAILURE ANALYSIS OF ELASTOMER COMPONENTS

## **Explosive Decompression and Explosive Overheating – Strong and Sudden Changes in Pressure or Temperature Can Cause Severe Sealing Damage**

Authors:

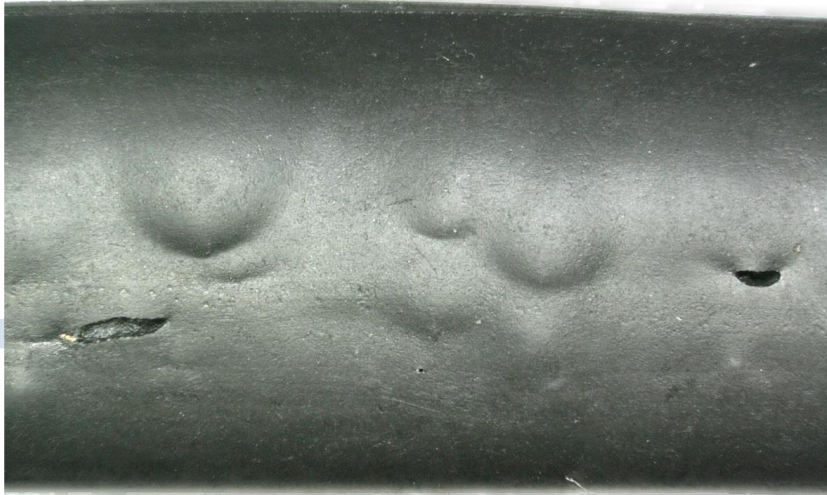
**Fig. 1:** Bubbles on the surface and cracks in the circumferential direction due to explosive decompression

Immediately after the relaxation there are often bubbles on the surface, which usually disappear again. Typical permanent damages are cracks in the core, which partially propagate to the surface, see **Figs. 1 and 2**. The damage pattern of explosive evaporation is not fundamentally different from explosive decompression, see **Figs. 3 and 4**.

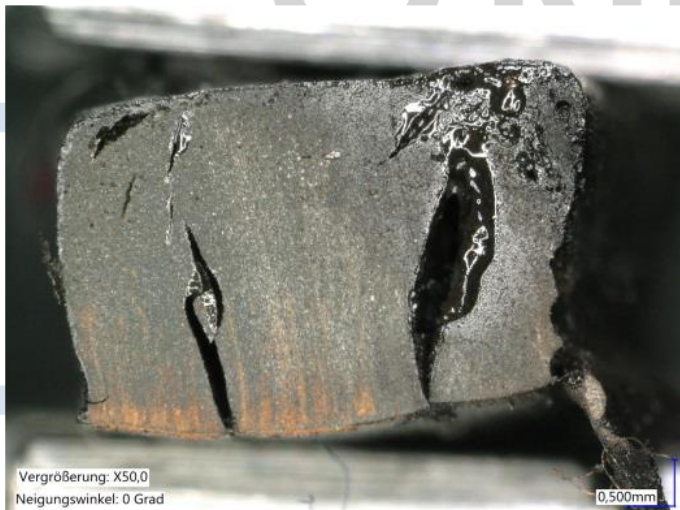
**Fig. 4:** Internal cracks due to explosive overheating or explosive evaporation

In many cases in explosive overheating, cracks are more numerous and smaller. The internal crack formation is typical for the damage mechanism of an explosive superheat.
