# **EXPERT KNOWLEDGE** **FAILURE ANALYSIS** **OF ELASTOMER COMPONENTS** *SHORT VERSION*

Information as of 04/2018

## **Autoxidation – Rubber Poisons Can Accelerate Elastomer Aging Rapidly**

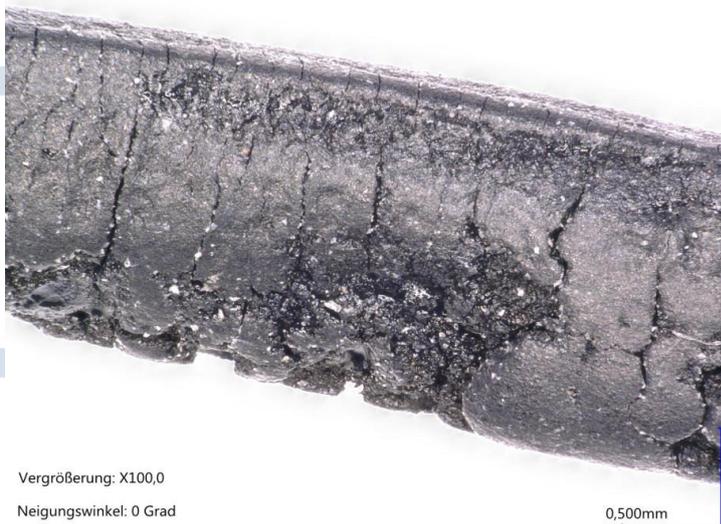
**Fig. 1:** EPDM O-ring, perox. cross-linked after endurance test (cyclic temperature change from 25 to 95° C in water with Cu ions, test duration 4500 h)

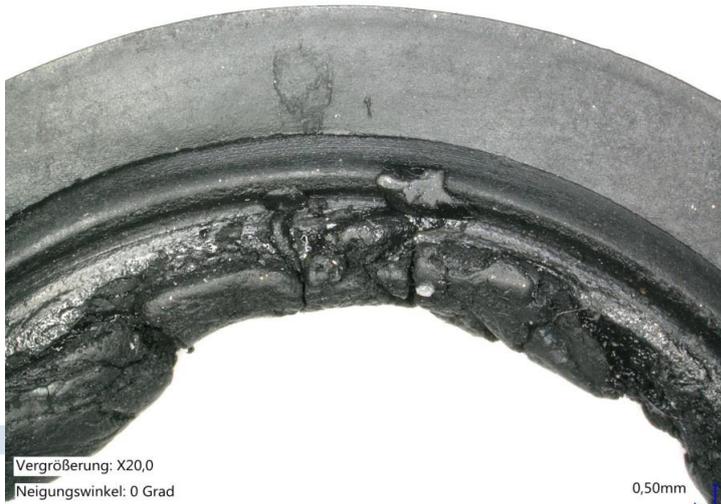
**Fig. 2:** EPDM seal damaged by autoxidation (dezincification) with clearly visible fused areas, similar to a thermoplastic or TPE

Damage caused by autoxidation often has a diverse appearance. Elastomeric materials can soften, crack, become sticky or shiny due to this mechanism. The shiny areas are often reminiscent of a melted thermoplastic. These characteristics can occur on the same gasket in different areas. In extreme cases, the seal may be completely depolymerized, resulting in decomposition and even carbon black.

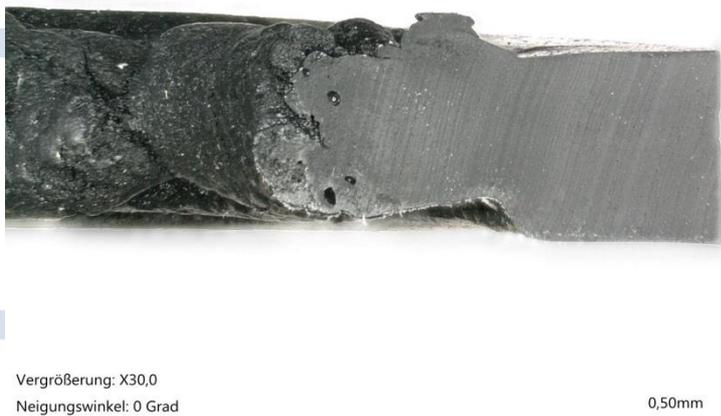
**Fig. 3:** Seal from Fig. 2 in cross-section. The left area had contact with rubber poisons, the right area was protected by the housing.
