EXPERT KNOWLEDGE FAILURE ANALYSIS OF ELASTOMER COMPONENTS

Information as of 07/2019

High Permanent Deformation – If the Gasket is "Stuck"

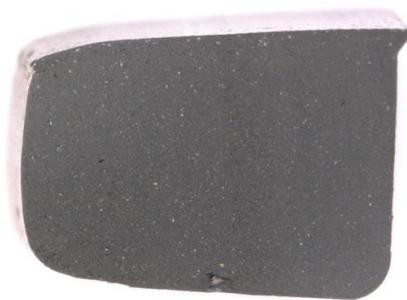
Fig. 3: Permanent deformation due to chemical degradation - the stronger degree of deformation in the left area can be clearly seen (medium side)

- The seal is exposed to substances that lead to chemical degradation. These can be aggressive cleaning or sterilization substances in process engineering or highly additive oils or other aggressive fluids. If this suspicion is obvious, the seal can be examined for traces by means of a GC-MS analysis.

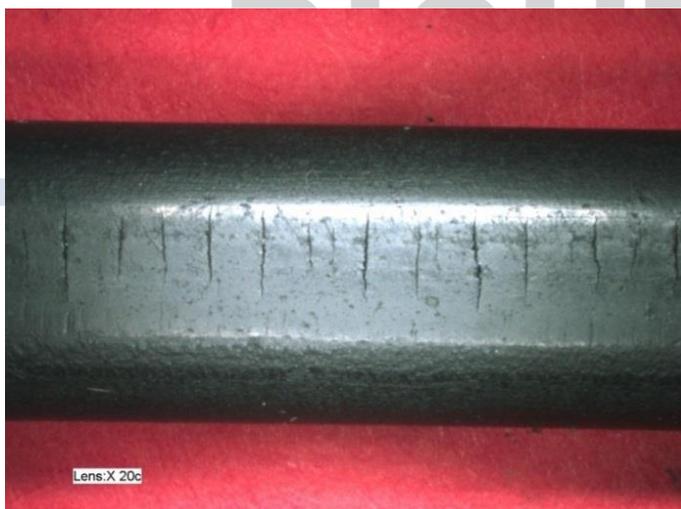
Fig. 4: In addition to permanent deformation, a typical impermissible thermal stress is complete embrittlement, which is shown here in crack formation after slight bending stress in the contact area of the seal.

In addition to the permanent deformation, a significant increase in hardness is often typical for this damage mechanism, and the seal also breaks at a slight bending stress or shows crack formation. This is a sign that the formulation-specific material stress limit for heat and chemical resistance has been reached.

Other important characteristics of a damage pattern to be investigated are whether it still behaves typically rubber-elastic, whether the hardness (**Fig. 4**) has changed significantly and/or whether the volume of the seal has decreased considerably. This then allows an evaluation of the damage pattern. Residual compression deformation measurements can further confirm the assumptions made.

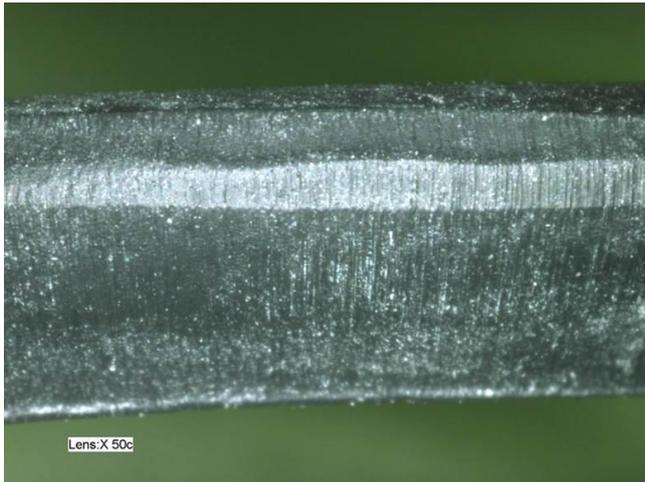
Fig. 6: Plan view of the outer diameter of the damaged O-ring from Fig. 5 with clear marks from the abrasion process.

At first glance, the cross-section of an O-ring that has failed due to excessive abrasion can be confused with a high permanent deformation. When comparing the cross-sectional area of an abraded O-ring with that of a new O-ring, however, it quickly becomes clear that the cross-sectional area of an O-ring damaged by abrasion is missing. Since rubber materials can initially be regarded as incompressible, no significant surface change occurs with a high permanent deformation, but only a rearrangement of surfaces. In addition, the abraded ring often shows grinding marks, see **Figs. 5 and 6**.
