# O-ring failure: The true causes

## An evaluation of more than 500 failure analyses

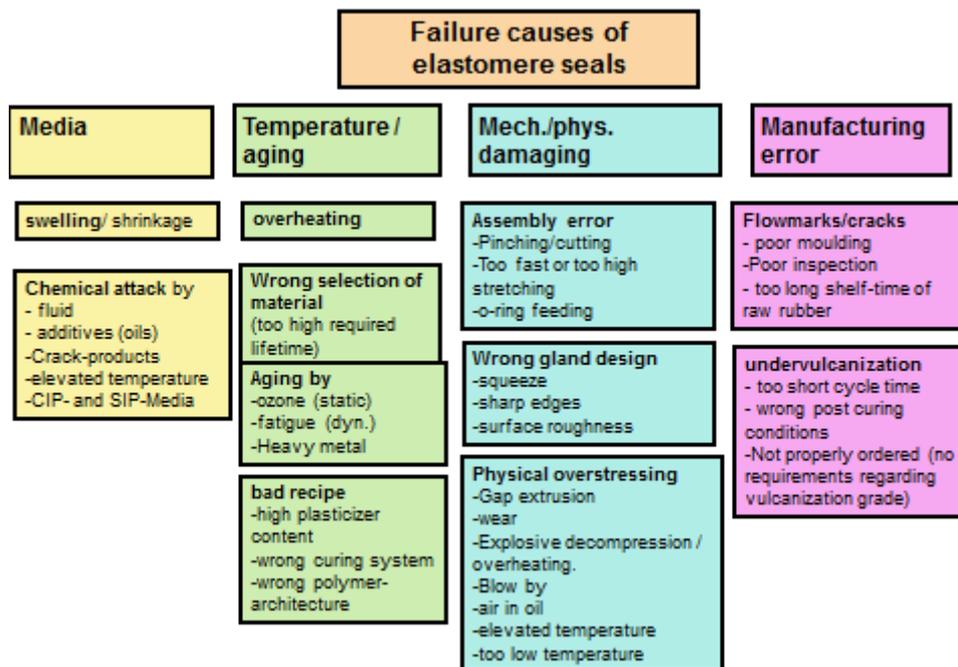
Figure 1 – Classification of the failure causes

The classification of failure mechanisms in four different classes has proven to be useful (**Fig. 1**):

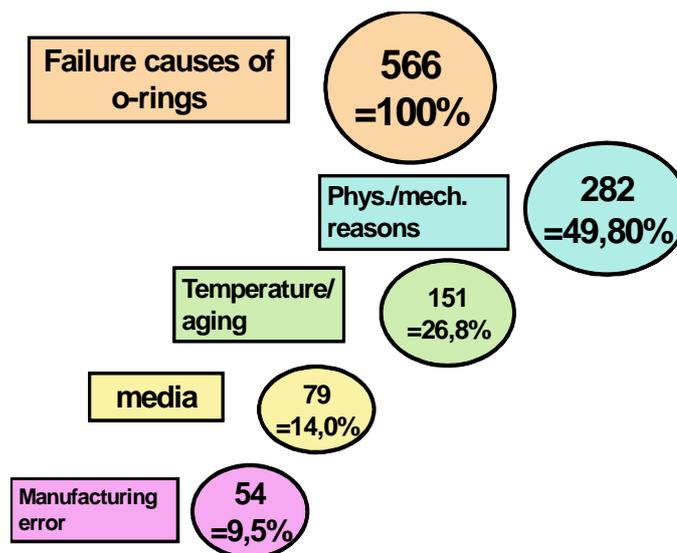
Figure 2 – distribution of failure causes

566 failure analyses of O-ring seals result in a distribution according to **Fig.2**, regarding the different failure causes described above. It should be mentioned that in some cases a combination of different causes lead to a failure. Those failures were classified regarding the dominating failure cause. Furthermore, it should be clear that indications are being analyzed, as no “eyewitnesses” are existant. As a result it may happen that in some particular cases, despite of all acurateness and a common belief in ones own competences, indications aren’t evalueted correctly, especially if there is a lack of information concerning the failure conditions. It is remarkable that the distribution of failure causes after 110 (1<sup>st</sup> evaluation) and after 180 (2<sup>nd</sup> evaluation) failure analyses, was almost similar to the distribution after 566 analyses (**Fig.2**). This fact can be seen as an indicator for a good representation of reality.

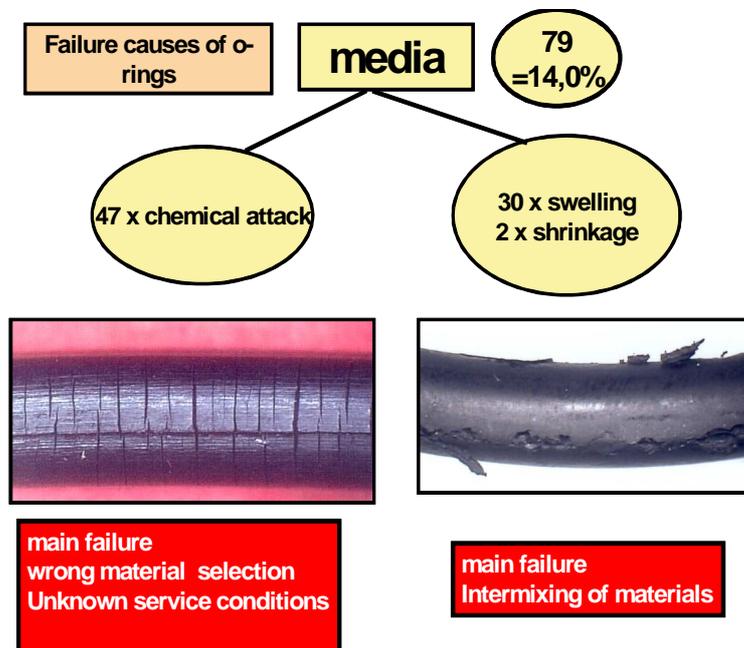
Figure 3 – unacceptable contact with media

An unacceptable contact with media causes either a destruction of the materials’ network structure (= chemical attack) or an unacceptable swelling (**Fig.3**). While unknown operating conditions or a wrong material selection are common reasons for a chemical attack, a swelling is often caused by a confusion between different materials due to carelessness in the storage or handling of O-rings (EPDM O-rings may come in contact with oil). A common mistake concerning chemical attacks is the usage of standard FKM recipes (Co-polymer, bisphenolic cured) in cooling water applications due to the common belief that FKM-materials are a general “problem solver” as far as O-rings are concerned. Additionally, the application of chemical aggressive cleaning and sterilization media in sterile process engineering is underrated regularly.

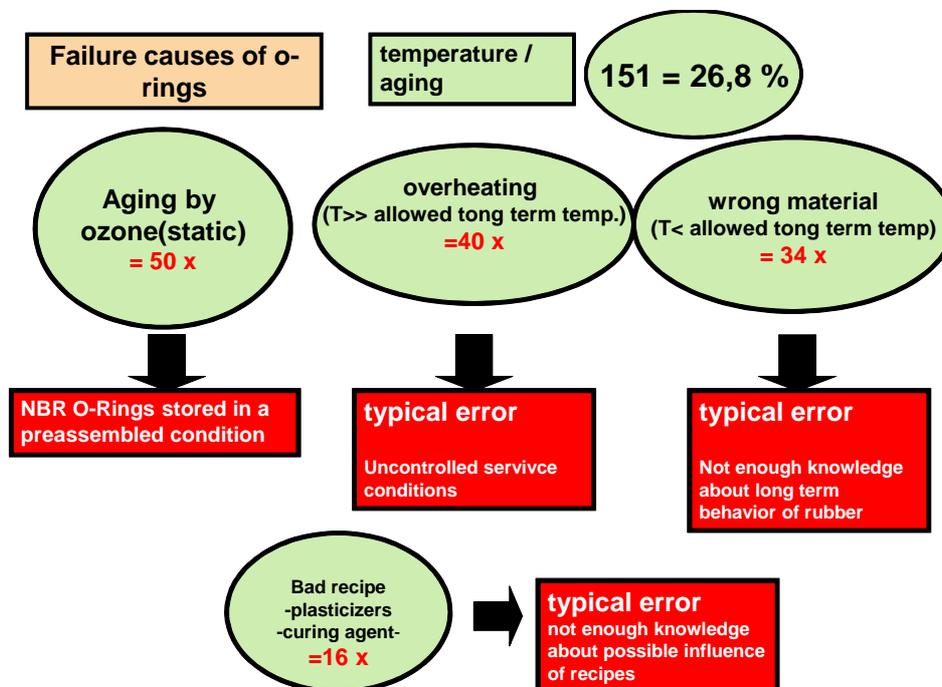
Figure 4 – failure causes due to ageing (heat and oxygen)

Ageing is defined as a change in the chemical and/or physical properties of a material during storage or usage. This evaluation doesn't include the influence of the sealed media; therefore the failure causes summarized in this group are reduced to the effects of heat and oxygen (**Fig. 4**).

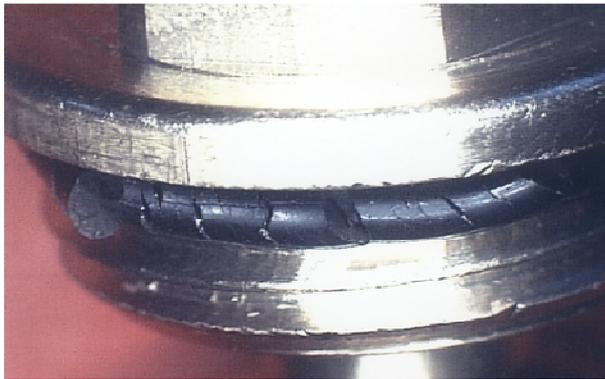
Figure 5 – failure cause: ozone cracks

**Fig.5** shows the damage symptoms of a failure due to “ozone cracks”. Ozone cracks occur frequently at pre-assembled NBR O-rings that are exposed to ozoniferous ambient air without protection over a long period of time (at least several days).

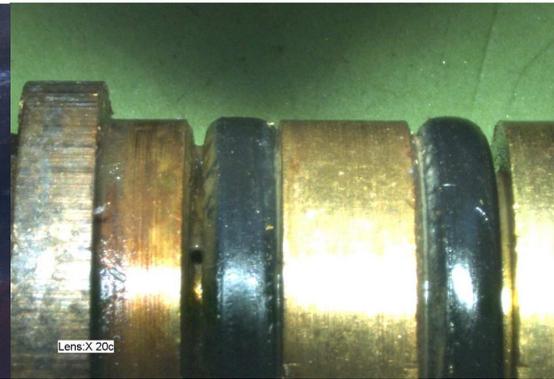
Figure 6 – failure cause: permanent deformation/brittling

**Fig.6** shows the damage symptoms of damaged NBR O-rings. The failure occurred after 1-2 years due to embrittlement and a permanent deformation at temperatures less than 80° C in a hot water application. As the user expects a minimum life-time of 5 to 10 years, peroxide cured EPDM O-rings would have been the right choice for this application.

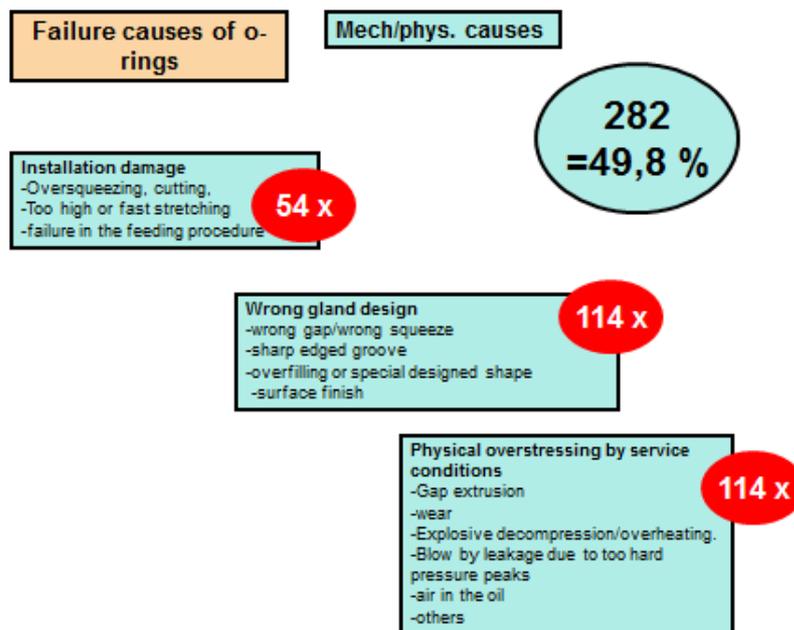
Figure 7 – Failure causes due to physical/mechanical effects

This group summarizes all failure causes that are able to give an explanation of the failure without any changes in the network structure of the material but doesn't imply any manufacturing defects. A remarkable fact, regarding **Fig.7** is that a lot of failures don't occur due to common causes like gap extrusion, abrasion or explosive decompression, in fact a lot of O-rings fail due to less spectacular reasons like assembly faults or wrong clearance design. This verifies the fact that a majority of design engineers doesn't pay enough attention to the design and the dimensioning of O-ring seals. Therefore, there is a need for action, in particular to qualify and sensitize the design and production engineers to this topic, in order to attach higher value to the field of O-ring seals.

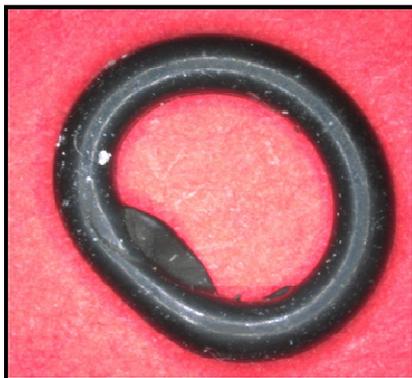
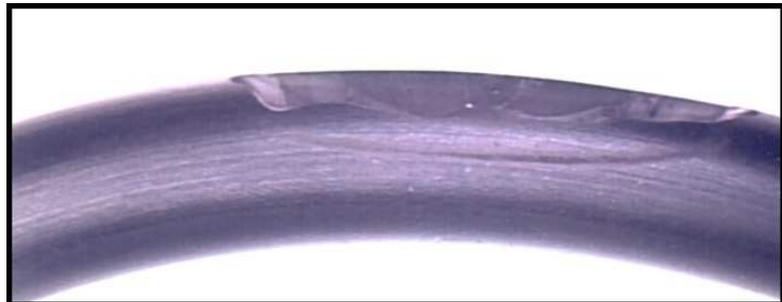
**Fig. 8 and 9** show typical examples of assembly faults that usually occur due to a bad design of the inlet and/or a lack of lubrication. Surprisingly high, namely 20.1%, is the rate of failures due to bad design and dimensioning of the clearance. That implies sharp edges, less or too much deformation, an overfilling of the clearance, clearance of diameter or poor surface quality (**Fig.10**). Only after that failure causes like gap extrusion, abrasion (**Fig.11**) and explosive decompression/explosive overheating come into play. Less well-known failure causes like dynamic caused overflowing (blow-by effect) or air in the oil [E1] are worth a mentioning too.

Figure 8 – installation damage

Figure 9 – installation damage

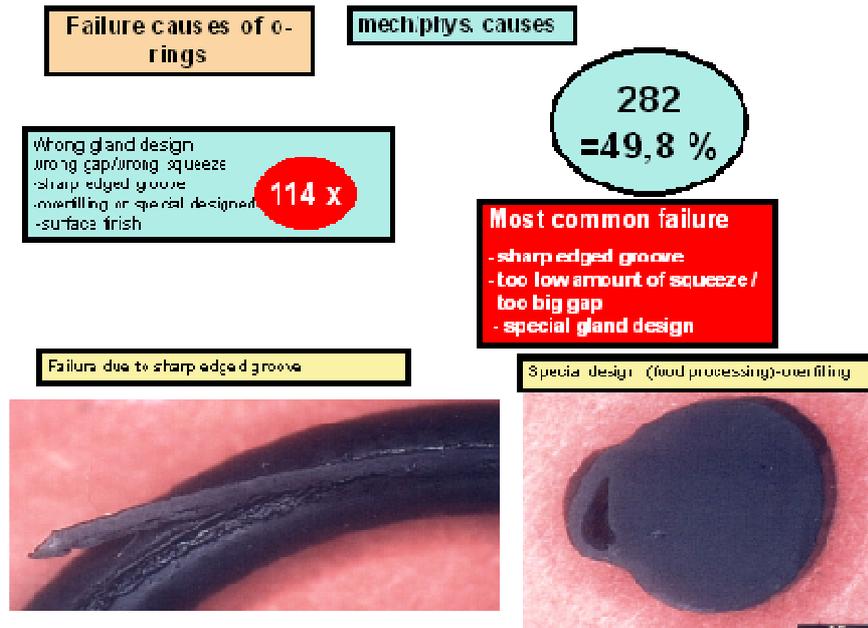
Figure 10 – failure cause: wrong gland design

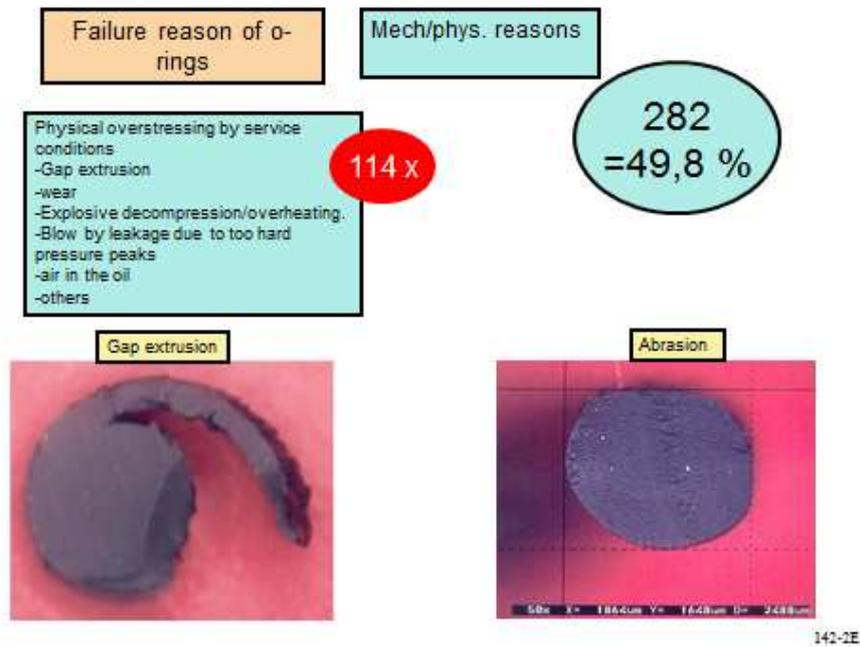
Figure 11 – failure cause: gap extrusion and abrasion

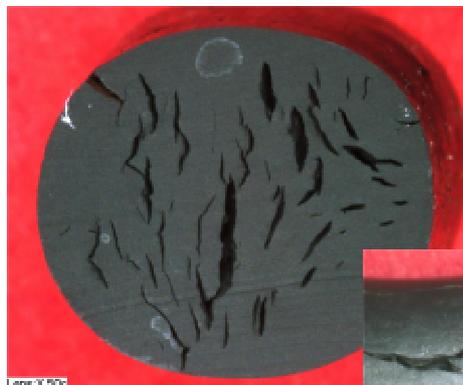
Lens: X 500x

A swollen O-ring gets heated higher than the boiling point of the absorbed medium within a short amount of time

Burst FFKM O-ring after application in a mechanical seal at 16 bar and 165° C in water. Damaged due to either multiple overheating during start or temporary dry-running.

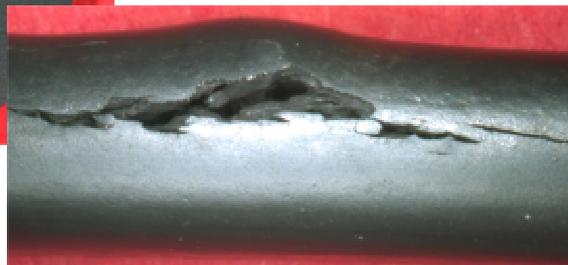
Figure 12 – failure cause: explosive decompression

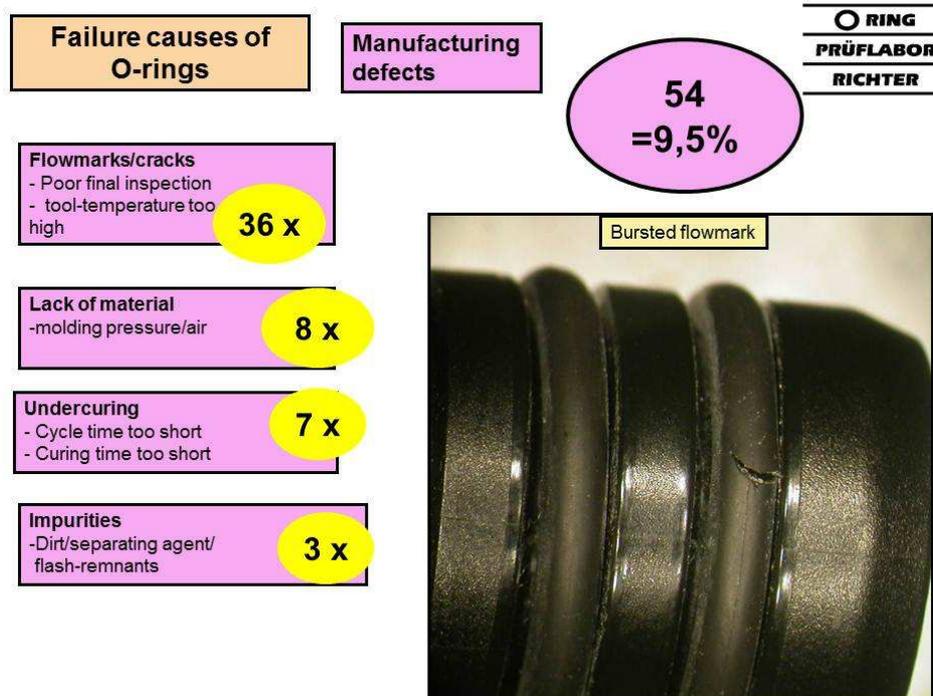
Figure 13 – manufacturing defect

Manufacturing defects are defects that develop during the manufacturing process of the O-rings (Fig.13). Thereby, peroxide cured EPDM and FKM O-ring show a high sensibility to flow-marks due to their bad processability, however this fact is not always considered during

manufacturing process and final inspection. And due to assembly stress, a harmless looking flow-mark may result in a deep crack and thereby lead to a leakage.
