Why O-Rings Fail

Several O-Ring failure modes for O-Rings and their causes

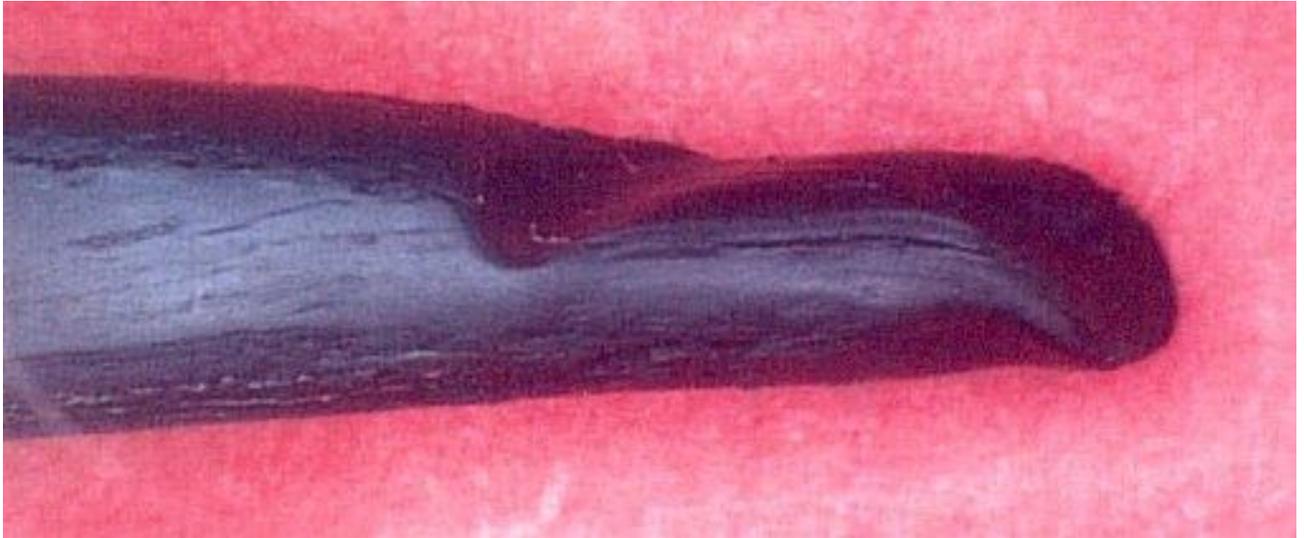
O-Rings that come in contact with sharp edges can be damaged and can lead to subsequent failure. This damage can occur not only in the gland area when crossing over counter bores or channels, Photo 3, (another frequent problem are sharp

Photo 3: Sheared o-ring from passing over flow channel during assembly.

Avoid assembly defects through careful design of gland and O-Ring lead-in guide chamfers. Reducing assembly friction of O-Rings greatly reduces assembly risk as well. Related is the flatness and roundness of o-rings (minimal „ potato chip“ and ovality); allowable tolerances should be agreed upon with the O-Ring supplier. With

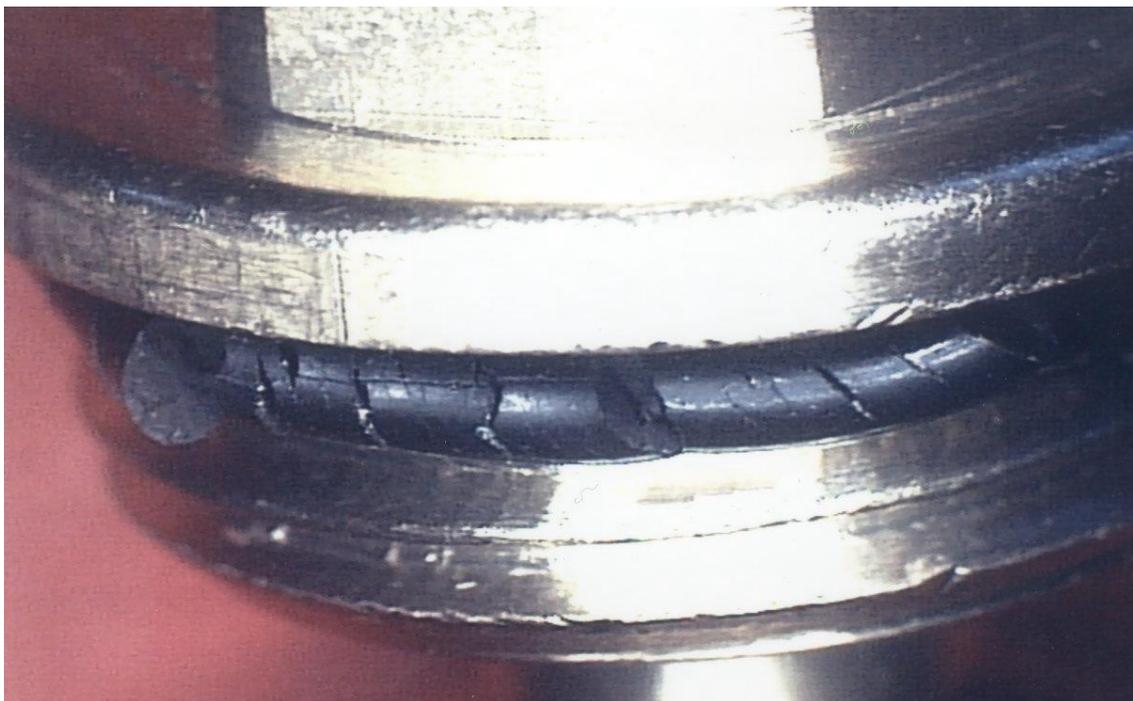
One should be careful when using NBR o-rings in environments where o-rings assembled on sub-components that are temporary stored prior to final assembly; exposure to air and weather can cause ozone cracks even after a short period of time, see Photo 5. This requires that pre-assembled NBR o-rings in temporary storage for more than several hours be protected from air and direct light. If this is not possible it is recommended that as minimum, an NBR recipe with improved ozone resistance be used, otherwise an ozone resistant elastomer such as EPDM or FKM be used.

Photo 5: Ozone splits on an assembled o-ring on sub component following several weeks in storage without light and air protection.

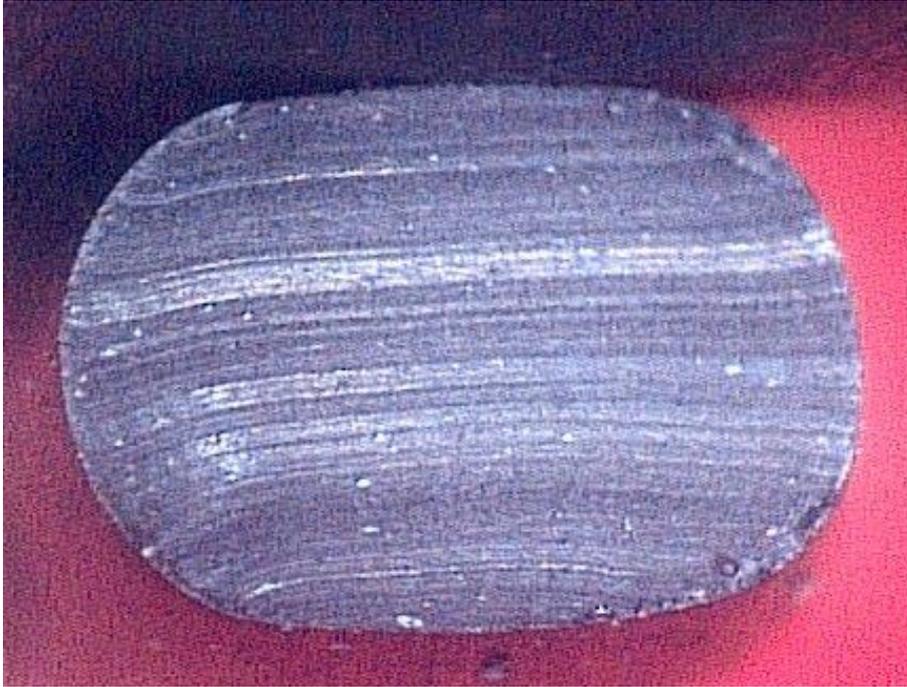
Often underestimated are the influences of formulation and process quality of O-Rings. If O-Rings are of a poor quality formulation (ie high plasticizer content) or poorly vulcanized, severe compression set can result in just a few weeks or months, Photo 7. As a preventive measure, a compression set specification for production O-Rings should be established, as merely providing a data sheet for the material is not adequate assurance that O-Rings are properly vulcanized. Additional procurement requirements are naturally prudent as they relate to ensuring good vulcanization practices and material quality.

Photo 7: Permanently deformed O-Ring.

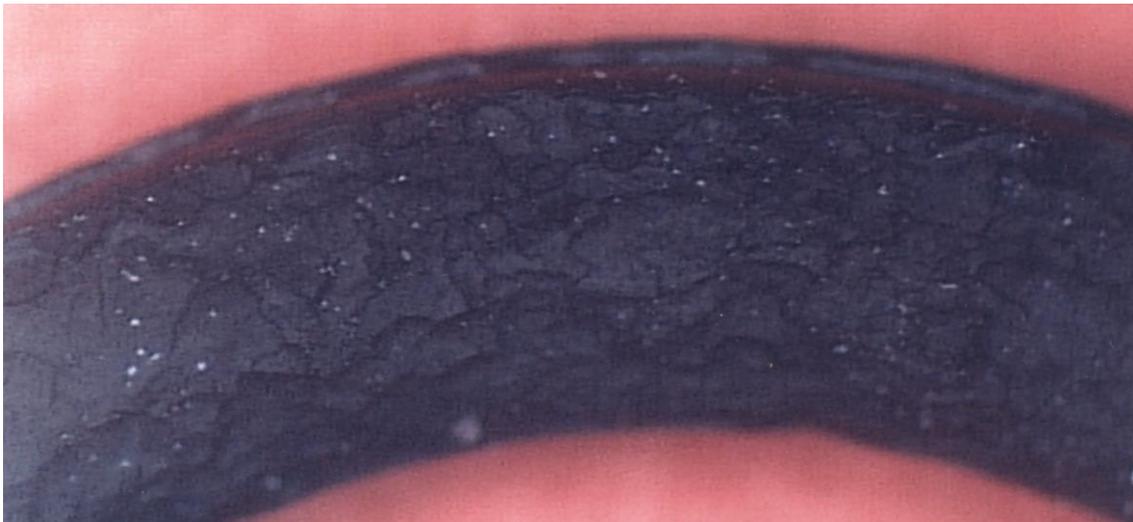
Mineral oils under increasing pressure dissolve increasing amounts of air that can expand in an explosive manner very quickly upon sudden pressure drops, resulting every so often in damage to the O-Ring, Photo 13. Unlike extrusion, the damage occurs on the pressure side of the O-Ring.

Photo 13: Damage from explosive decompression of air.
